# THE WOOD SUPPORTS OF THE PAINTINGS IN THE HALL OF KINGS: A TECHNICAL STUDY OF ITS CONSTRUCTION, STATE OF CONSERVATION AND TREATMENT

BENJAMÍN DOMÍNGUEZ-GÓMEZ

UNIVERSIDAD DE SEVILLA

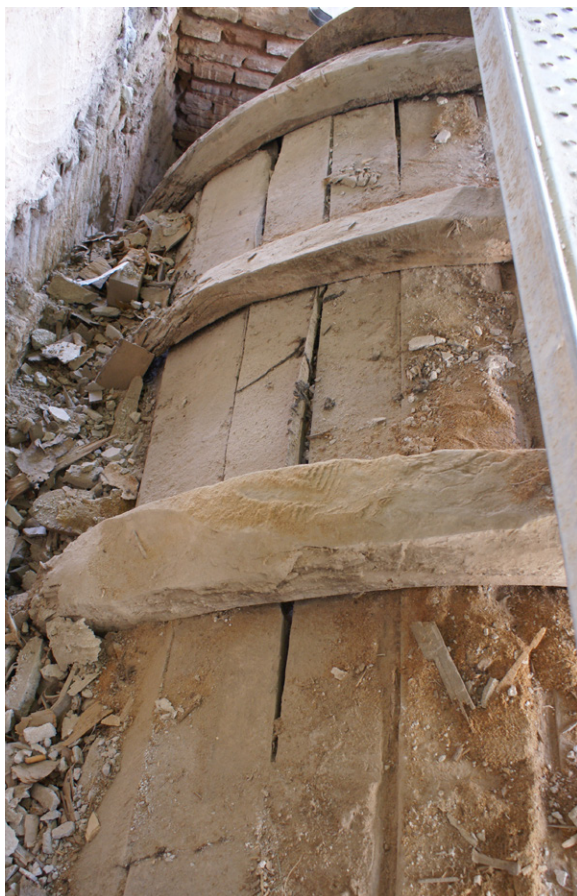
Il. 4: Vault 3. State of conservation prior to the intervention. Benjamín Domínguez, Vault 3. State of conservation prior to the intervention, 2007. GESTIONARTE S.L.U.

led to the growth of a fungal colony as a result of the ambient humidity in the rafters, leaks from the guttering in the roof, and the accumulation of all this hygroscopic material. On top of the vaults, a thick layer of dust and surface deposits (including rodent droppings) covered the entire ensemble (Il. 4).

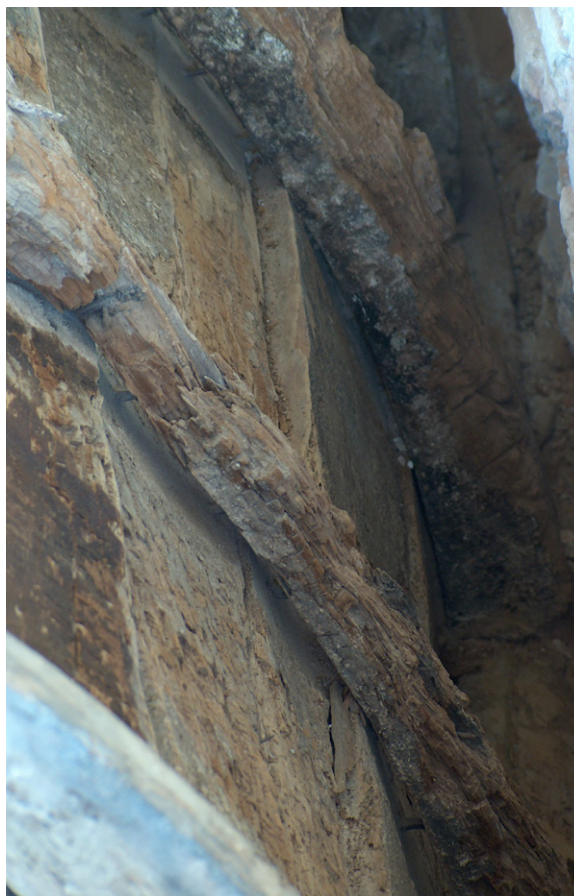
Il. 5: Vault 3. Detail of rot in the ribs. Lions area. Benjamín Domínguez, Vault 3. Detail of rot in the ribs. Lions area, 2007. GESTIONARTE S.L.U.

The attack by wood-decay fungus was without doubt the most destructive alteration suffered by the three vaults. It was more extensive on the side of the reverse sides adjoining the Courtyard of the Lions, although the fungus also appeared in some parts of the wood on the Partial side and in the ribs. As a result of this decay, the wood suffered extensive damage, revealing a friable surface typical of “brown rot” (Il. 5).

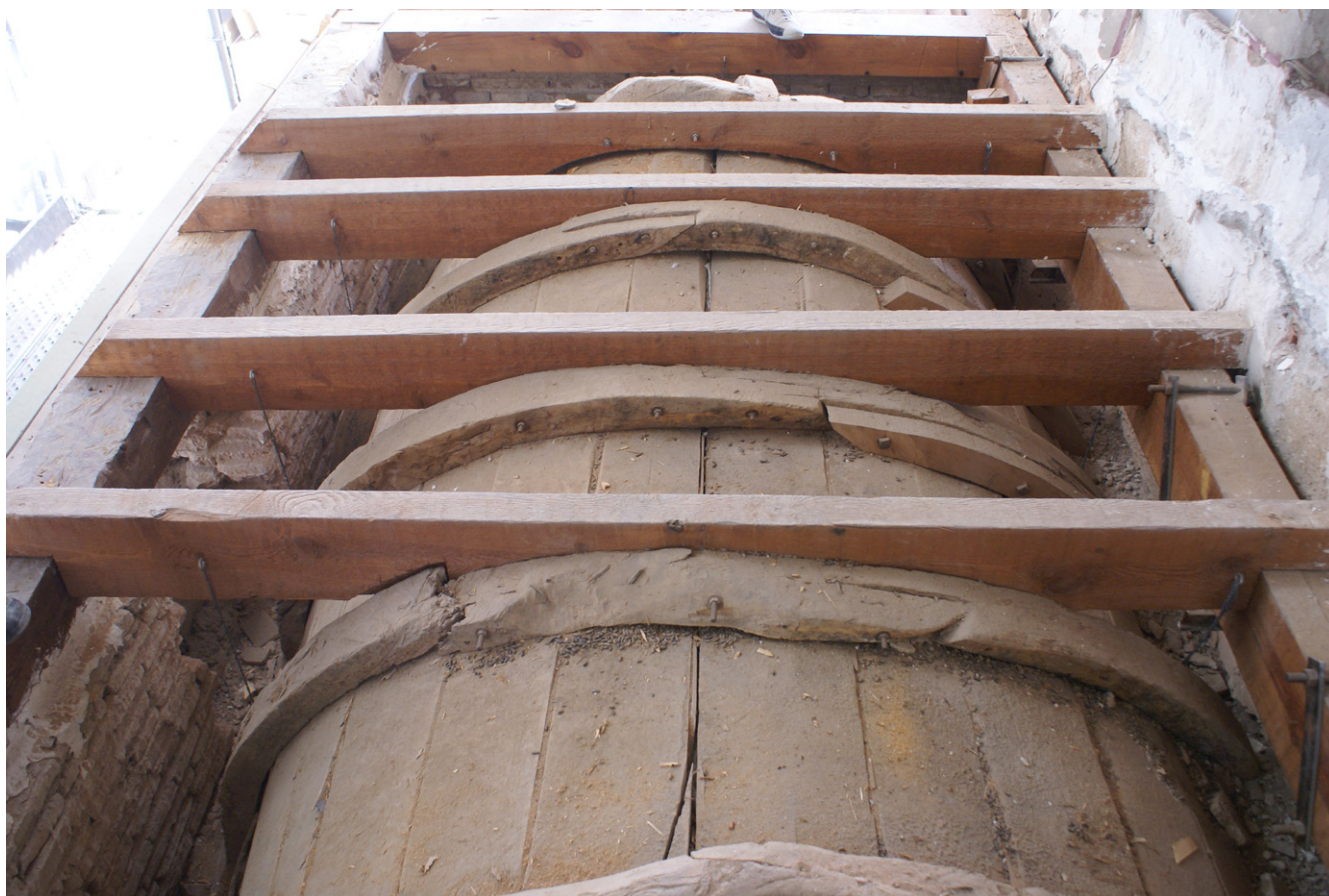
Il. 6: Vault 1. Reinforcements added in the 1980 intervention. Benjamín Domínguez, Vault 1. Reinforcements added in the 1980 intervention, 2007. GESTIONARTE S.L.U.

Vault 1 was the focus of conservation efforts at the end of the 20th century presumably because it was in the most dangerous condition. It has been subject to more intervention than the other vaults, at least in terms of the support. As we have said, it would also not be surprising if it had already lost many of its constituent elements by the time of the 1980 intervention. These alterations can be seen, for example, in the central axis of the semicircumference, the highest part of the vault, which had come away by 4cm and was deformed, with evident signs of warping in the panels. Furthermore, the load of the structure is not well distributed, as several of the original parts that made up the ribs and the base ring have disappeared (Il. 6). The most noteworthy alteration in Vault 2 was the high incidence of the wood decay and the reinforcements or “crutches” added in the intervention of the 1980s. Their installation involved making cuts in the healthy ribs and cutting out the rotten ribs, which resulted in a loss of original volume (Il. 7). Following on-site observations of the method and the nature of this intervention, we can only assume that there was an event that prevented the intervention in Vault 2 from being completed.

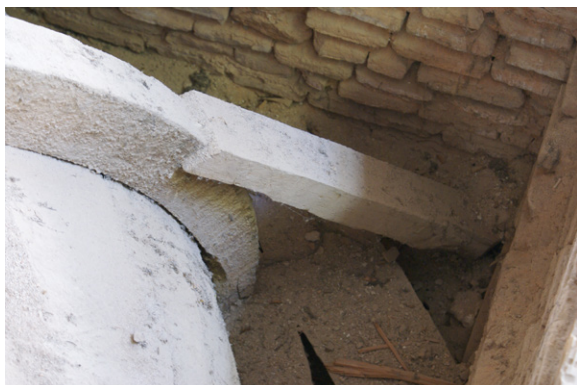
Il. 7: Vault 2. Reinforcements or “crutches” added as part of the actions undertaken in the 1980s. Benjamín Domínguez, Vault 2. Reinforcements or “crutches” added as part of the actions undertaken in the 1980s, 2007. GESTIONARTE S.L.U.

In addition to the areas “in precarious condition” due to their evident deterioration, there were others that were not self-supporting and which had been subject to previous intervention, such as Vault 1 as a whole or Vault 2, which was unique to the others in that it was supported by a series of “crutches”, as described above.

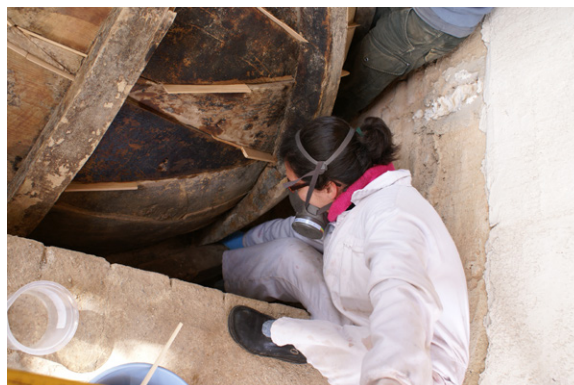
Il. 8: Vault 3. Conservation-restoration treatment. Difficulty in accessing some areas significantly hampered the application of some treatments. Benjamín Domínguez, Vault 3. Conservation-restoration treatment. Difficulty in accessing some areas significantly hampered the application of some treatments, 2007. GESTIONARTE S.L.U.

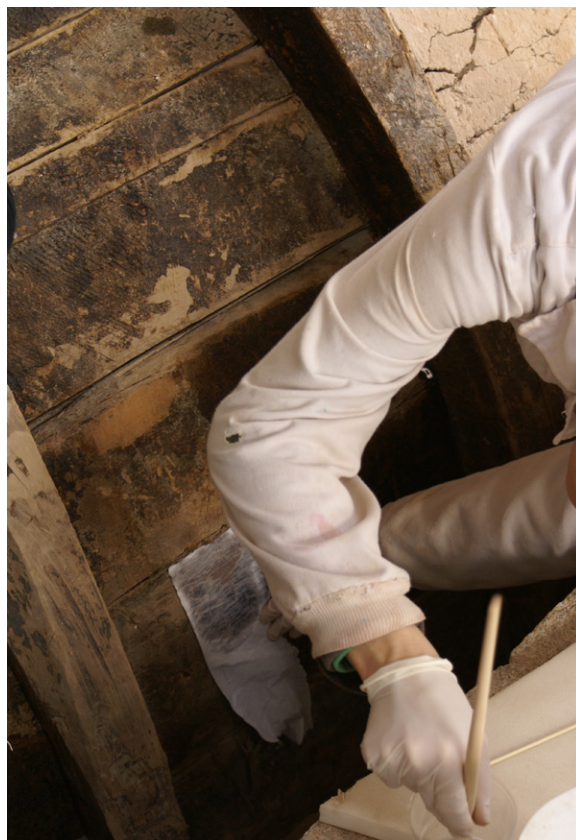
Il. 9: Vault 3. Conservation-restoration treatment. Cleaning process. Benjamín Domínguez, Vault 3. Conservation-restoration treatment. Cleaning process, 2007. GESTIONARTE S.L.U.

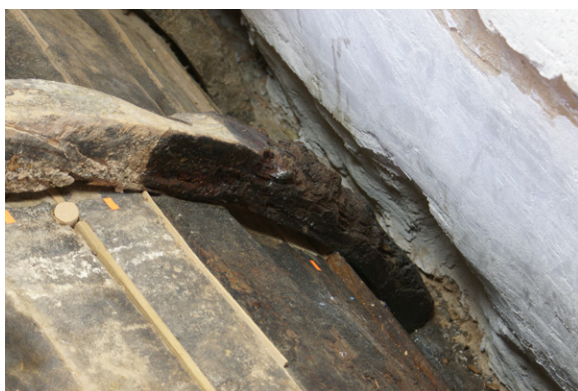
Il. 10: Vault 2. Conservation-restoration treatment. Consolidation of wood affected by rot. Benjamín Domínguez, Vault 2. Conservation-restoration treatment. Consolidation of wood affected by rot, 2007. GESTIONARTE S.L.U.

At the request of the external technical adviser, Jean Albert Glatigny, the wood support attacked by wood-decay fungi was consolidated using an epoxy resin based on Araldite AY103 and HY926 (base resin and catalyst) despite its irreversible nature. It should also be noted that this operation was particularly difficult, given the characteristics of the work site: limited space, verticality, difficulty in finding a position in which to work in, etc.<sup>31</sup> (Il. 10).

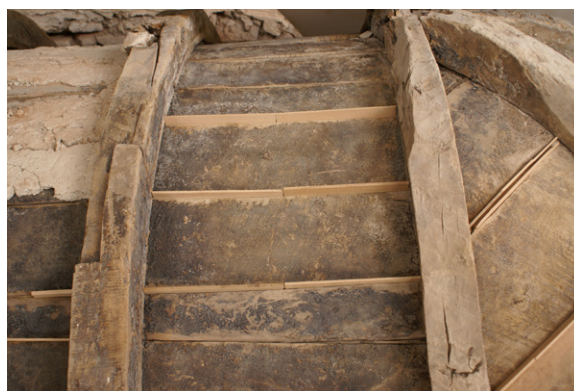
Il. 11: Vault 1. Conservation-restoration treatment. Filling of the openings between the boards with pieces of cedar. Benjamín Domínguez, Vault 1. Conservation-restoration treatment. Filling of the openings between the boards with pieces of cedar, 2007. GESTIONARTE S.L.U.

Once suction cleaning had been performed in each of the joints and openings, they were measured, assessed and checked against the damage mapping undertaken during the project study phase. In general, in all openings larger than 1mm, a chip of red cedar wood<sup>32</sup> was inserted in the same direction

as the wood grain so that it would interact with it, according to the changes in temperature and humidity. The inlays were glued with a water-based polyvinyl acetate (PVA) emulsion on one side of the joint only (so as not to prevent the wood from shrinking) and at the top of the board to limit the amount of dust falling from the board should it contract. Prior to this, each of the pieces was adjusted and cut – depending on each case – mechanically so that they could be inserted as neatly as possible. Any unevenness in the fissures was reproduced in the inserted pieces<sup>33</sup>. As expressly indicated in the project, the inlays do not pass through to the side bearing the paintings. On the reverse side, the parts exceed the dimensions of the boards by (+/-) 5 mm in order to retain dust (Il. 11).

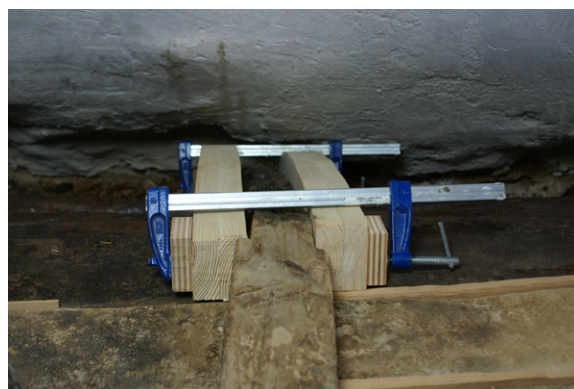
Il. 12: Vault 2. Conservation-restoration treatment. Positioning of reinforcements. Benjamín Domínguez, Vault 2. Conservation-restoration treatment. Positioning of reinforcements, 2008. GESTIONARTE S.L.U.

Consequently, and with the same criteria as for the base ribs, the ribs in the upper area were analysed, manufactured and replaced. We already had a precedent in this area, namely the 1980 intervention, and which has been maintained in those pieces that did not need to be removed for other reasons<sup>36</sup>. The reinforcements essentially consisted of making one or two pieces (depending on whether the requirement was to reinforce on one side only or to perform a “sandwich” type function) in wood and with the same curvature as the original rib. They were then put in place and joined to it by means of through dowels. Although the project envisaged the fitting of stainless steel bolts, it was felt during the process that it would be better to use wooden dowels as they would interact better with the other materials. However, in the “double ribs” from the 1980 intervention, the rusted iron bolts were replaced with stainless steel bolts with a thread diameter of 8mm and of the corresponding length. These were fitted with the corresponding washers. In some places, these rib reinforcements had a dual function: apart from reinforcing the upper area, they acted as a link with the base rib, as the original rib had rotted and disintegrated and could not be refitted. This function was mainly used in Vault 1, with the same criteria being applied in Vault 2, this time not only using pieces fitted as part of this intervention, but also existing reinforcements from previous interventions. Prior to assembling these pieces, it was essential to consolidate and restore the original wood in order to enable the correct adhesion and positioning of the reinforcements. Along with the positioning of the upper reinforcements, the pieces were replaced and the structure of the base ring consolidated, with all areas and supports being checked exhaustively to ensure they were safe (Ill. 12 and 13).

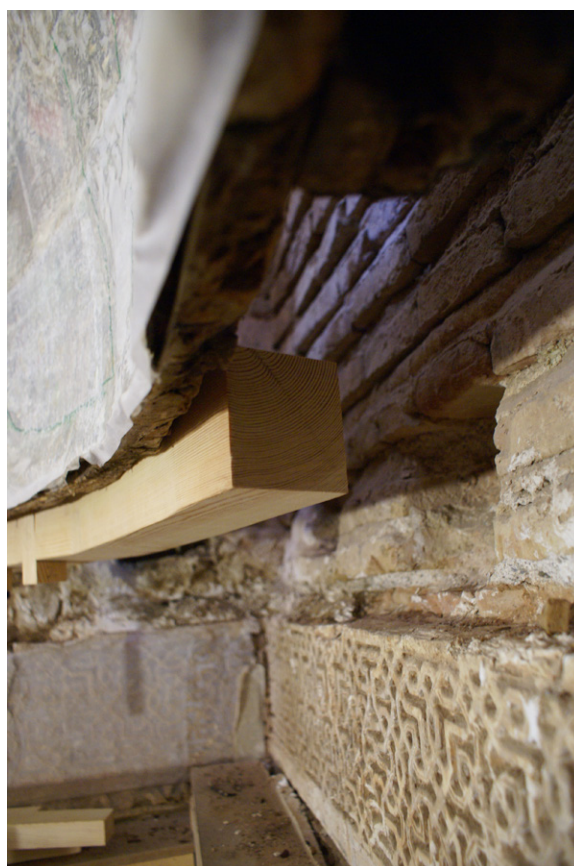
Il. 13: Vault 1. Conservation-restoration treatment. Reconstruction of the "base rib". Benjamín Domínguez, Vault 1. Conservation-restoration treatment. Reconstruction of the "base rib", 2008. GESTIONARTE S.L.U.

The replacement of the base ring and the “sandwiches” or replacements that were fitted and which have been described above, were made and fitted in line with a project that stated they should be made from Scots pine (*Pinus Sylvestris*), assembled in the same direction as the “wood grain” to enable interaction with it, according to changes in temperature and humidity. All newly manufactured parts were protected with a permethrin-based impregnation to protect them from biological attack and a Paraloid B-72 impregnation for the same purpose. The volumetric replacement pieces were fixed to the original support or to each other using a deionised water-based PVA emulsion. In many cases, due to the unevenness of the wood surface, Araldite SV 427/ HV 427 was used as an adhesive, which in turn allowed for the consolidation of the surrounding spaces. In addition to the adhesive, each of the pieces was tenoned to the original vault with wooden rods measuring 8mm to 14mm in diameter. This ensured they were mechanically fastened to them and provided a network of joints between all the pieces. The lower ends of the ribs and reinforcements in Vault 2 had to be partly cut so that they could fit the assembly boxes envisaged in the project. The pieces, once in place, were left in their original colour so that they could be identified from original parts in the future.
