THE MUQARNAS DOMES OF THE HALL OF THE KINGS: DATA FOLLOWING THEIR RESTORATION

RAMÓN FRANCISCO RUBIO DOMENE

HEAD OF THE PLASTERWORK AND TILING RESTORATION WORKSHOP OF THE BOARD OF TRUSTEES
OF THE ALHAMBRA AND GENERALIFE. PHD IN RESTORATION, UNIVERSITY OF GRANADA.

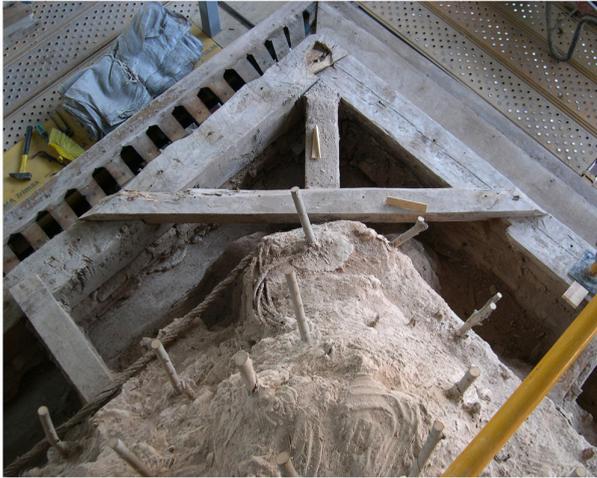
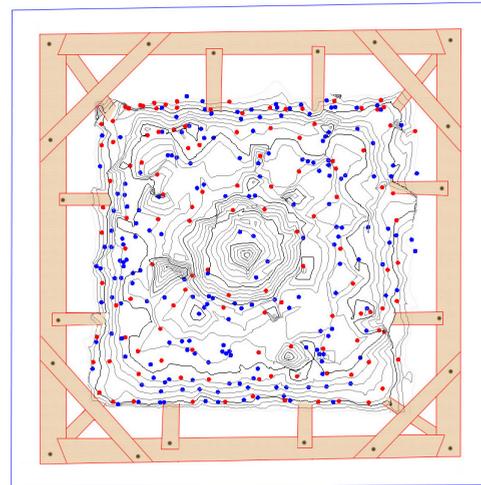
II. 3. Photographic detail of one of the corners of the reverse side of dome 2. After removing the roof, it was possible to see the sleepers, the wooden crossbeams of the cupola, a corner angle brace, the rope that fastens the cupola at its base, and the wooden braces from the 19th century works. On the right is a topographical survey with the contour lines of dome 2, and it is possible to see the wooden sleepers, which the crossbeams that the start of the dome hangs off are hooked to using grooves and fixed with nails. The location of the current stainless steel tensioners placed over the old holes from the 19th century works is in red, and the holes of the wooden braces that were also from the 19th century intervention but were not reused are in blue.

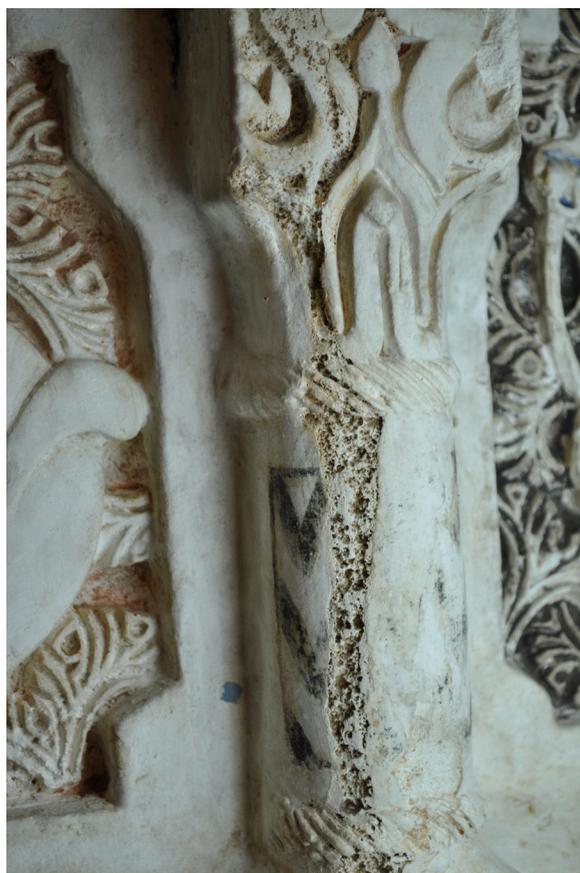
Il. 13. Detail of module 3, polychrome in vermilion-red applied in the Nasrid period, which has been hidden since the 19th century under a layer of

block module was under a layer of black plaster applied in the first restoration works, which hid and protected it from the direct action of both light and air over time. This means that it is in good condition and has a very intense colour, which gives us an idea of how intense the original Nasrid red would have been, and the great polychroming and intensity that these domes would have originally shown. Il. 13).

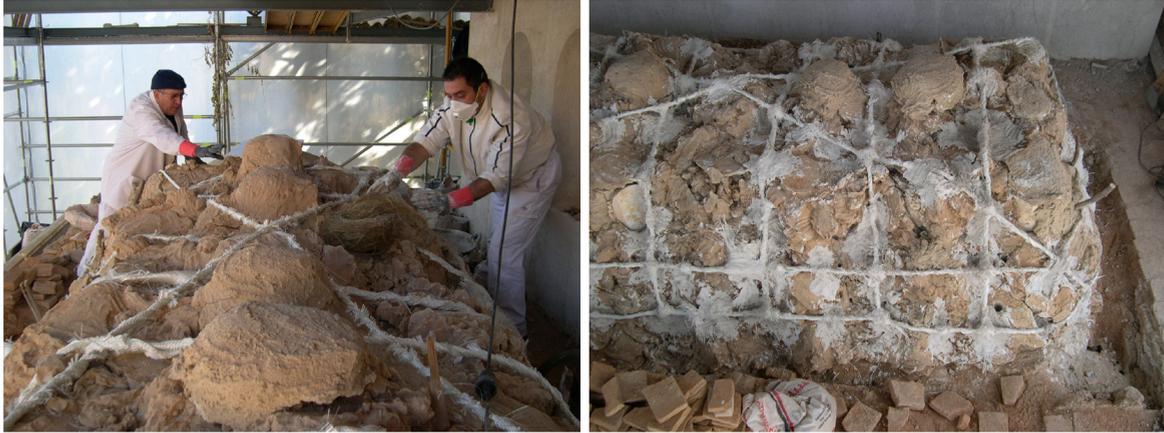
Il. 15. Restoration process that involved placing a fibreglass mesh fixed with esparto grass mixed with plaster on the back of dome 7.

Particular work was required for dome 7; due to its location at the northern end of the hall it had suffered greater damage from seismic movement, explosions, damp, etc. This meant that many cracks ran through the bulk of the dome, with displacement at its vertexes, and some of the muqarna block modules that formed motifs in the central cupolas had fallen off. Il. 14) This deterioration probably occurred prior to restoration work carried out during Rafael Contreras' time, when some cracks were covered with plaster and the corner modules were reconstructed. The first work we performed was to remove any plaster mortar that no longer fulfilled its function in order to lighten the weight. Once the dome, location and direction of all cracks had been studied, a fastening mesh was built and its fastening points could be adapted according to the presence and direction of the cracks. The mesh was made of fibreglass cord fixed with plaster and esparto grass fibre. It joined the entire dome, making all the detached areas solid.

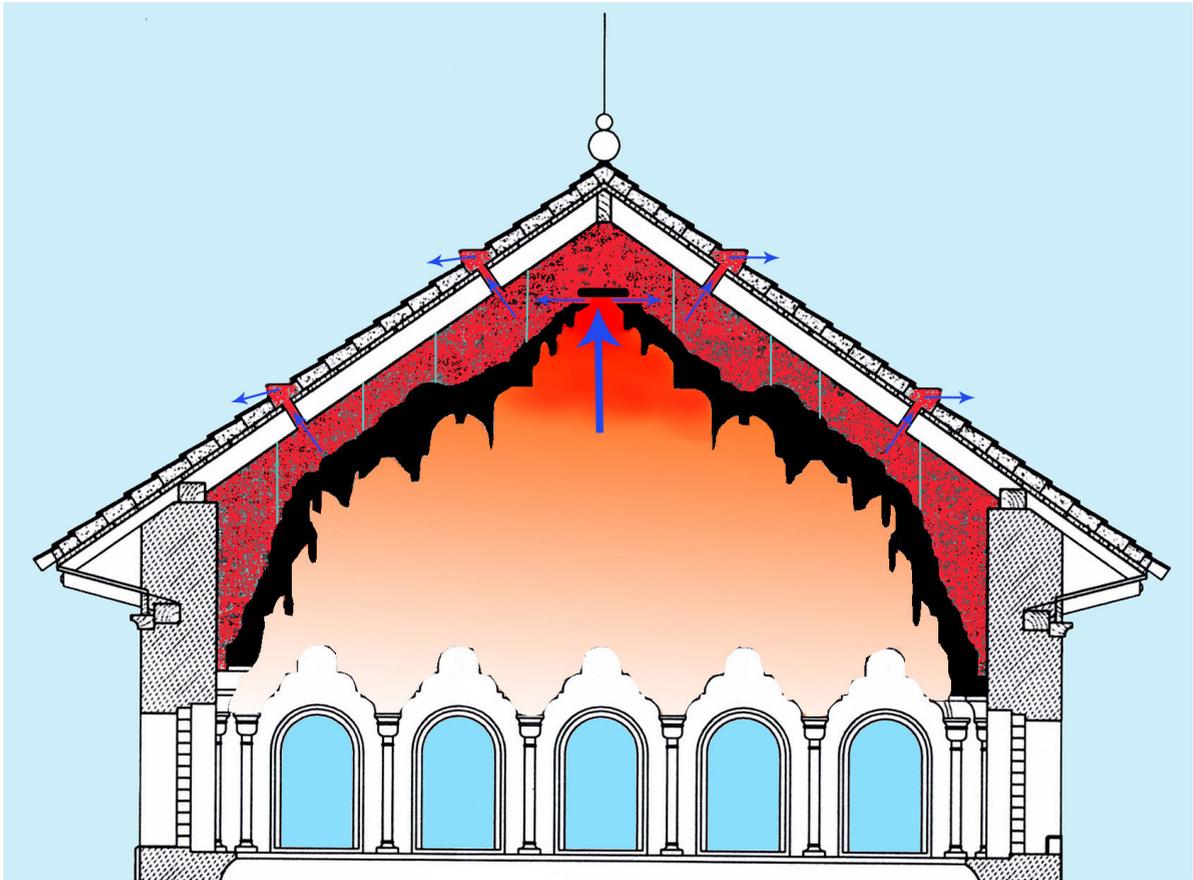
Il. 17. Installation of stainless steel metal braces on the back of the domes, fixed to the wooden rafters of the new roof.

Stainless steel bolts were placed in the holes in the thickness of the dome that were attached with plaster and esparto grass tied to a steel cable, and mechanically fastened at the other end to the wooden rafters of the new roof with a stainless steel through bolt. The length of the tensors was enough to ensure that they will not experience any load unless a situation occurs in which the dome detaches and possibly falls. Il. 17).

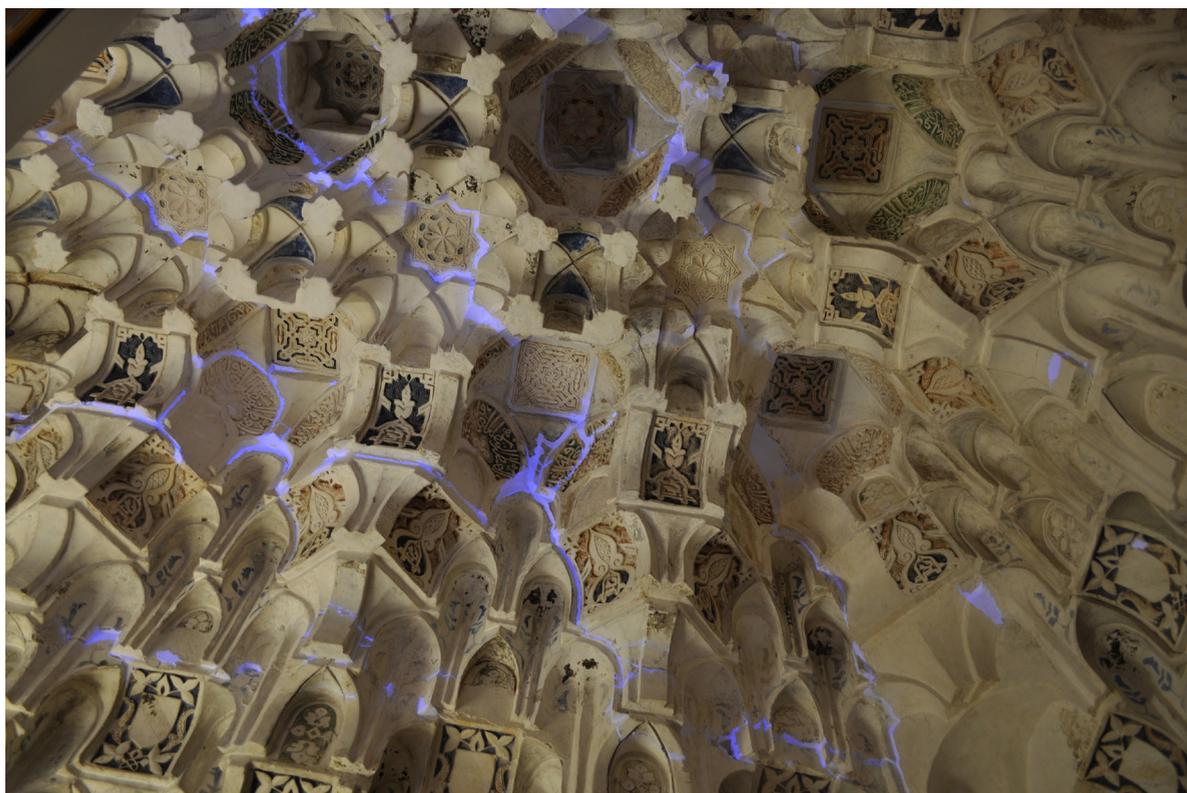
Il. 18. Photograph taken with ultraviolet light showing a detail of the final phase of restoring volume to dome 7, with work on all cracks and fissures using Alhambra plaster-based mortar.

The large cracks that hindered the readability of some of the modules were rebuilt, as were cracks found at the foot of the parapets, making these elements firmer and more secure. Larger cracks were filled and some of the loose elements were reattached. Alhambra plaster-based mortar was used in all these reconstructions due to its fluorescent properties, so that the restoration work could be located using ultraviolet light radiation. When necessary, due to the size of the fissures or cracks, esparto grass was added as a natural fibre to reinforce masses in cracks and large areas of loss. (Il.18)
