# THE SALA DE LOS REYES PLINTH RESTORATION

## LA RESTAURACIÓN DEL ZÓCALO DE LA SALA DE LOS REYES

## ALHAMBRA OF GRANADA. Plinth of the Hall of the Kings

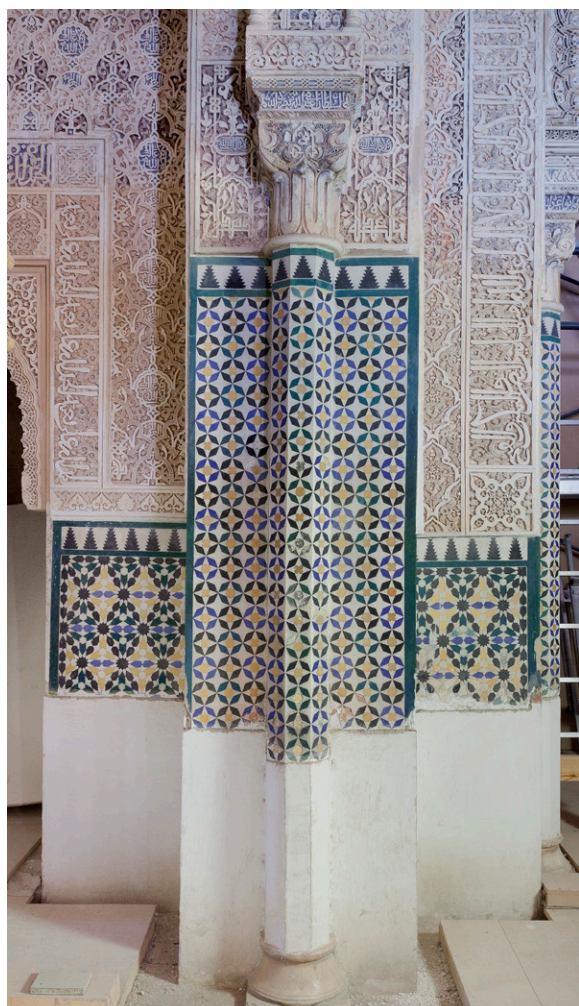
II. 2. © Ártico. Image of the state of the plinth before the work began. *Report on the conservation and restoration work on the plinth of the Sala de los Reyes. Alhambra (Granada). 2011-2012.*

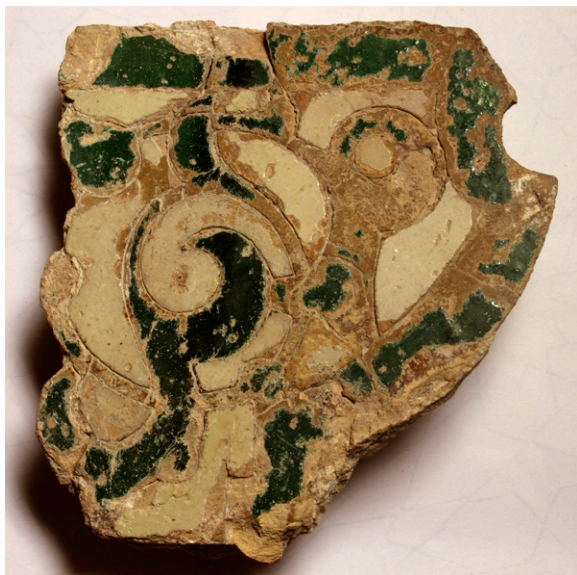
II. 3. © Ártico. Original piece of a base. *Report on the conservation and restoration work on the plinth of the Sala de los Reyes. Alhambra (Granada). 2011-2012.*

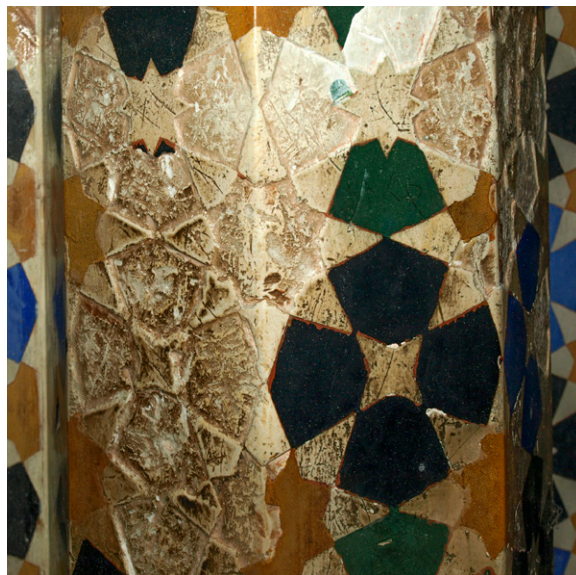
II. 4. © Ártico. State of conservation of the original tiling. *Report on the conservation and restoration work on the plinth of the Sala de los Reyes. Alhambra (Granada). 2011-2012.*

On the one hand, the original tiling focused on the incomplete panels of the two pillars on the north side of the hall, which were made with glazed tiles in the five traditional Islamic colours of white, green, blue, honey-coloured and black. Gentle mechanical cleaning was carried out. In order to consolidate a specific area of the adobe wall with lime mortar, two small ceramic pieces were removed and reinstalled using the same type of mortar with similar textural and chromatic characteristics to the original.

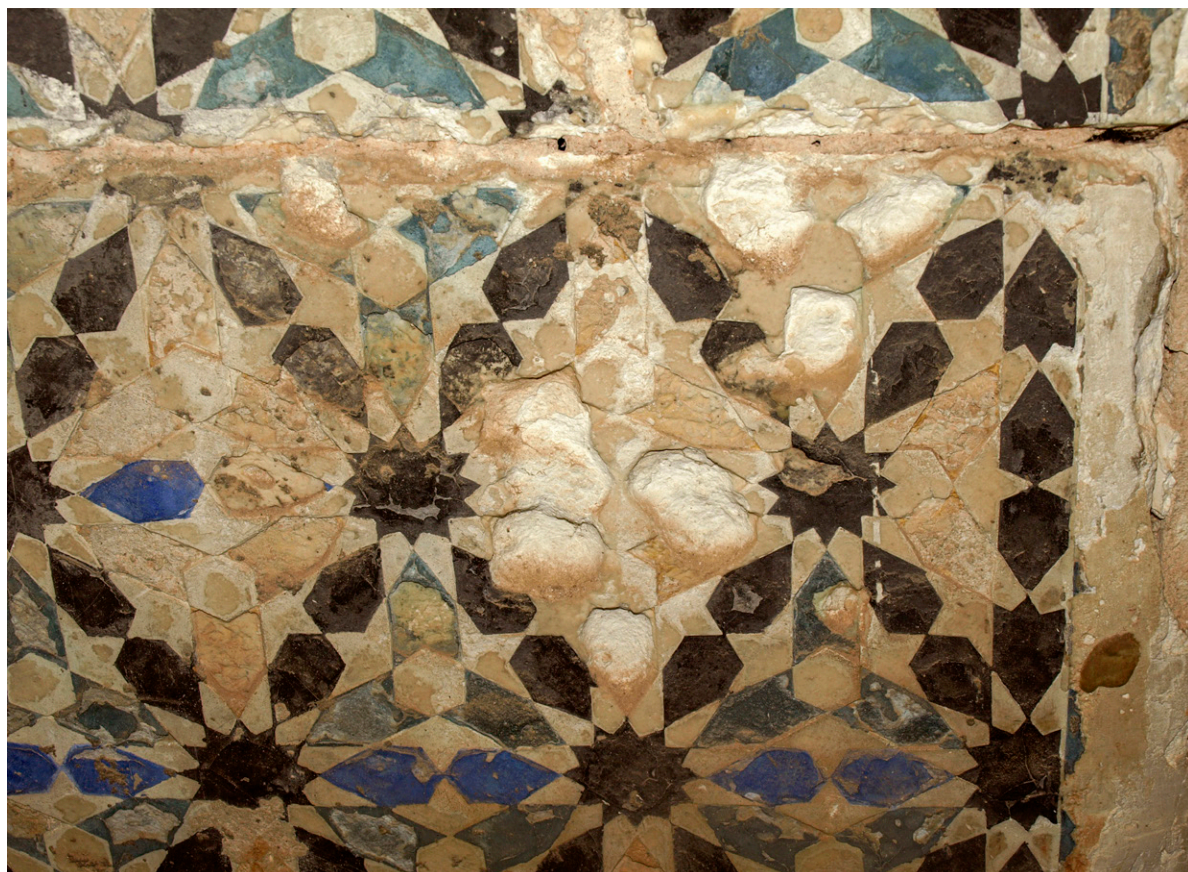
Unfortunately, a short period of time after the reproductions were mounted, the filtrations of the roof, the ambient humidity and no doubt the same humidity that had deteriorated the original plinth by capillarity, continued to act inexorably, seriously damaging the stuccoes, since during their mounting, no consideration was given to eradicating the source of the damage to prevent the destructive cycle from repeating itself. This fact was immediately brought to light when some scholars and visitors were able to see the Hall, and they questioned the performance and the result obtained.

II. 5. © Ártico. Degradation caused by damp on a panel with a stucco reproduction by Rafael Contreras. *Report on the conservation and restoration work on the plinth of the Sala de los Reyes. Alhambra (Granada). 2011-2012.*

in the brickwork. For this purpose, a ventilated and insulated cavity was chosen, with the stucco panels installed on inert supports, thus making the ornamental finish and, consequently, the action of capillary rising damp independent of the wall support itself. The intervention was definitively guaranteed by the major renovation of the hydraulic installations in the Palace of the Lions.

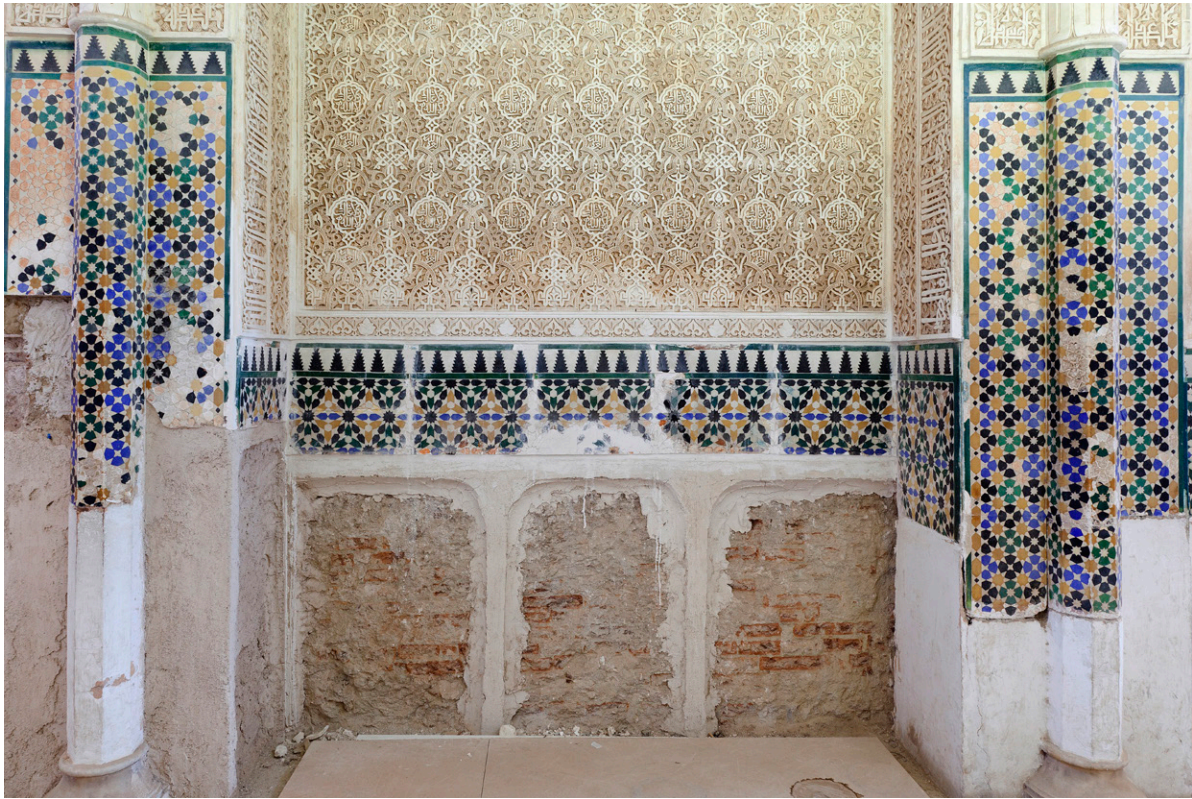
II. 6. © Ártico. Preparation and restoration of the walls. *Report on the conservation and restoration work on the plinth of the Sala de los Reyes. Alhambra (Granada).* 2011-2012

Initially, the walls that were to receive the new reproductions were cleaned and consolidated by repairing their surfaces, filling in cavities and fixing unstable ceramic elements.

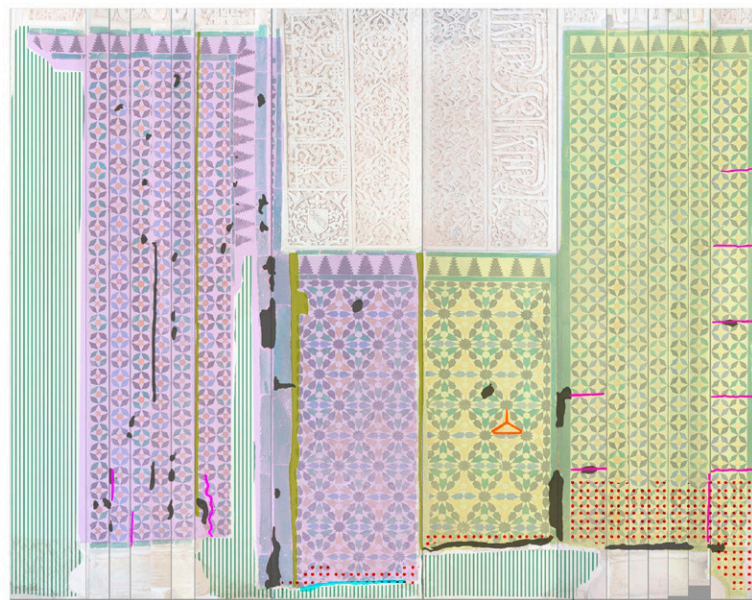
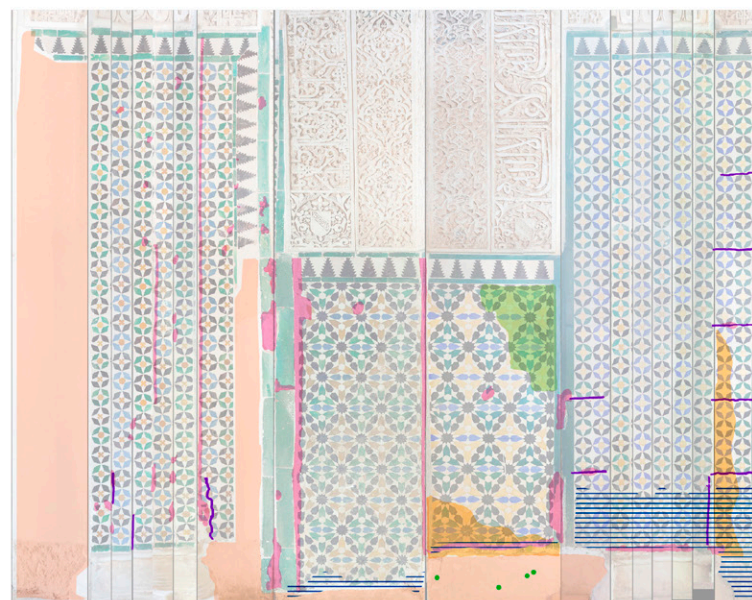
## BUTTRESS 1

STATE OF CONSERVATION

- Volume losses (ceramic/stucco)
- Disaggregations
- Efflorescence
- Graffiti
- Metal elements
- Cracks and fissures

II. 7. © Ártico. Damage mapping of Buttress 1 with original tiling. *Report on the conservation and restoration work on the plinth of the Sala de los Reyes, Alhambra (Granada).* 2011-2012.

INTERVENTION

- Photonic cleaning
- Removal of metal elements
- Chemical consolidation
- Mortar injection
- Crack and fissure sealing
- Replacement of new panels
- Reintegration of volume and colour
- Installation of new panels

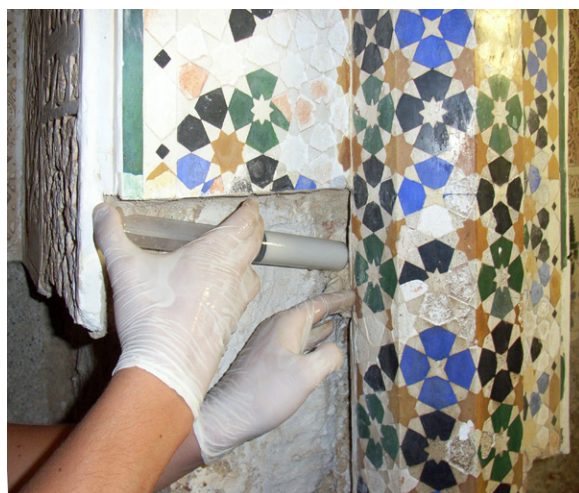
II. 8. © Ártico. Layer fixation. *Report on the conservation and restoration work on the plinth of the Sala de los Reyes, Alhambra (Granada), 2011-2012.*

bonded. Cracks and edges were also sealed, detached layers were fixed and volumes were reintegrated using mass-coloured plaster with the addition of fluorescent mineral particles. In some pieces with colour loss, small, discreet chromatic intonations were made.

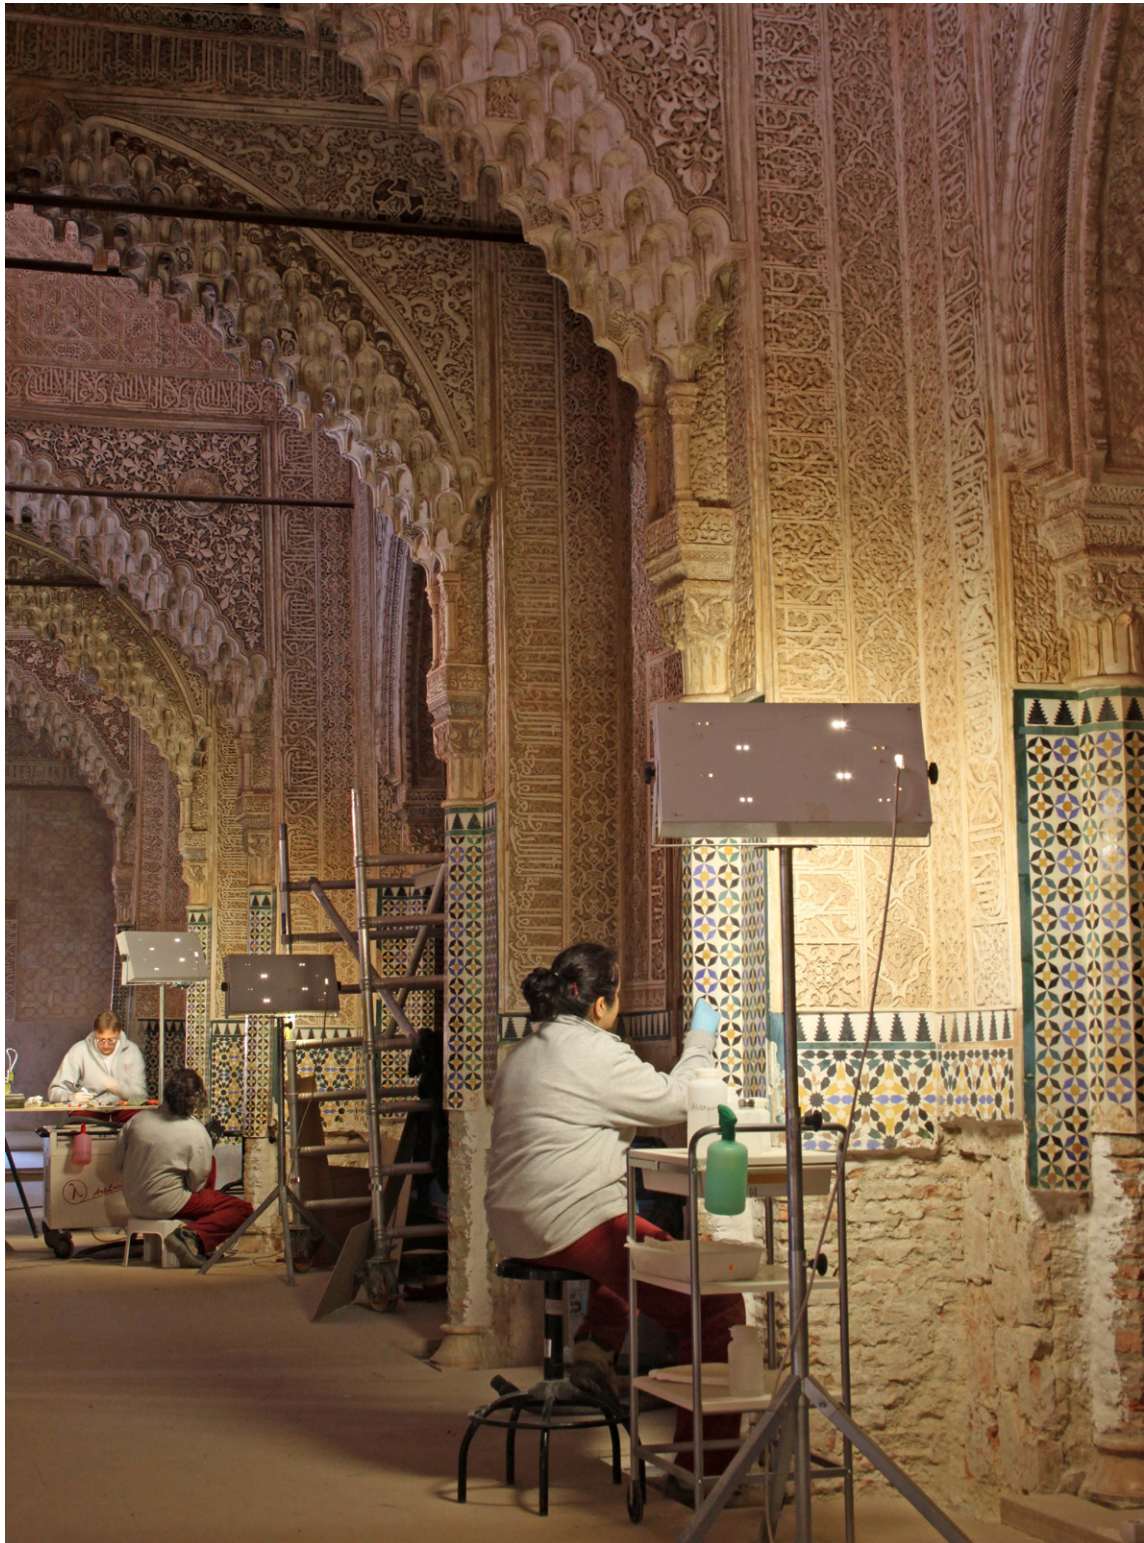
II. 9. © Ártico. Consolidation work. *Report on the conservation and restoration work on the plinth of the Sala de los Reyes, Alhambra (Granada). 2011-2012.*

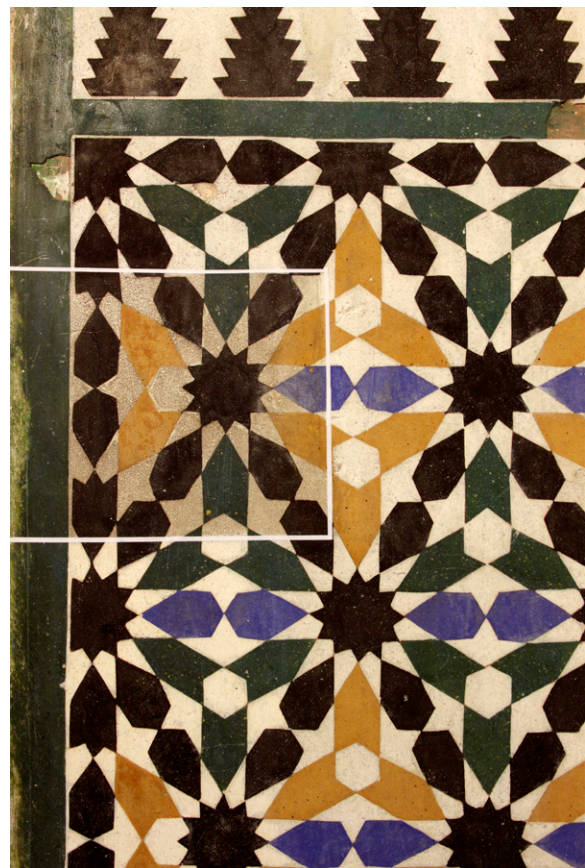
II. 10. © Ártico. Cleanliness indicator. *Report on the conservation and restoration work on the plinth of the Sala de los Reyes. Alhambra (Granada). 2011-2012.*

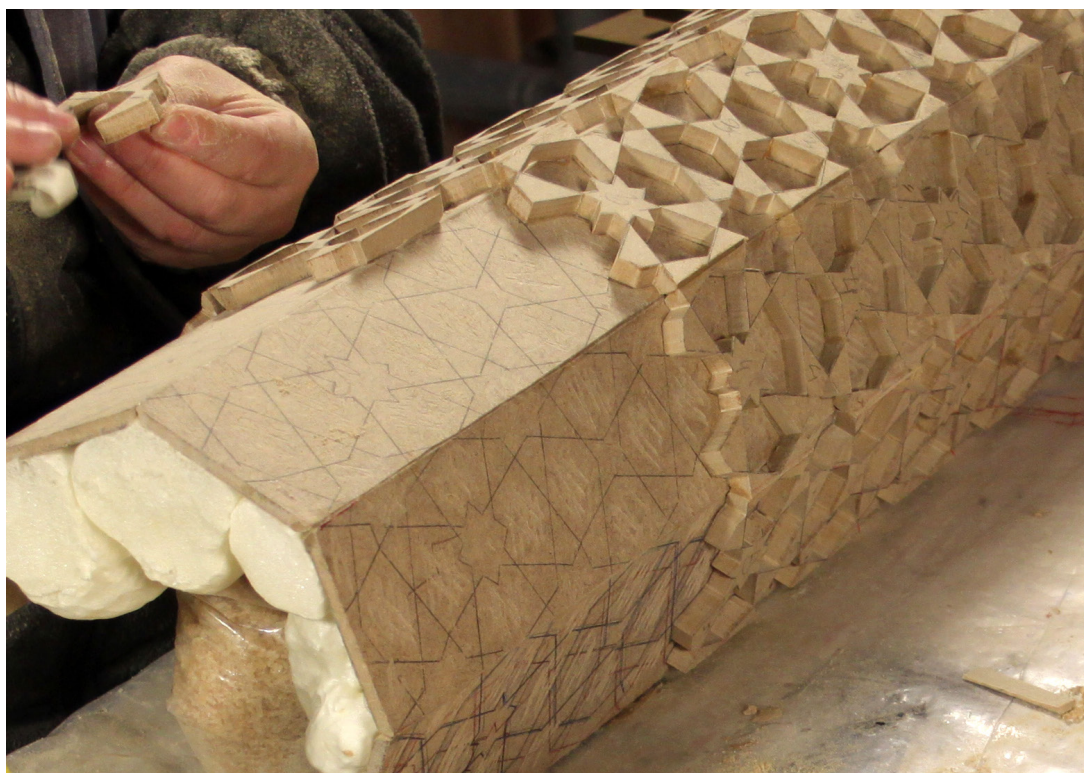
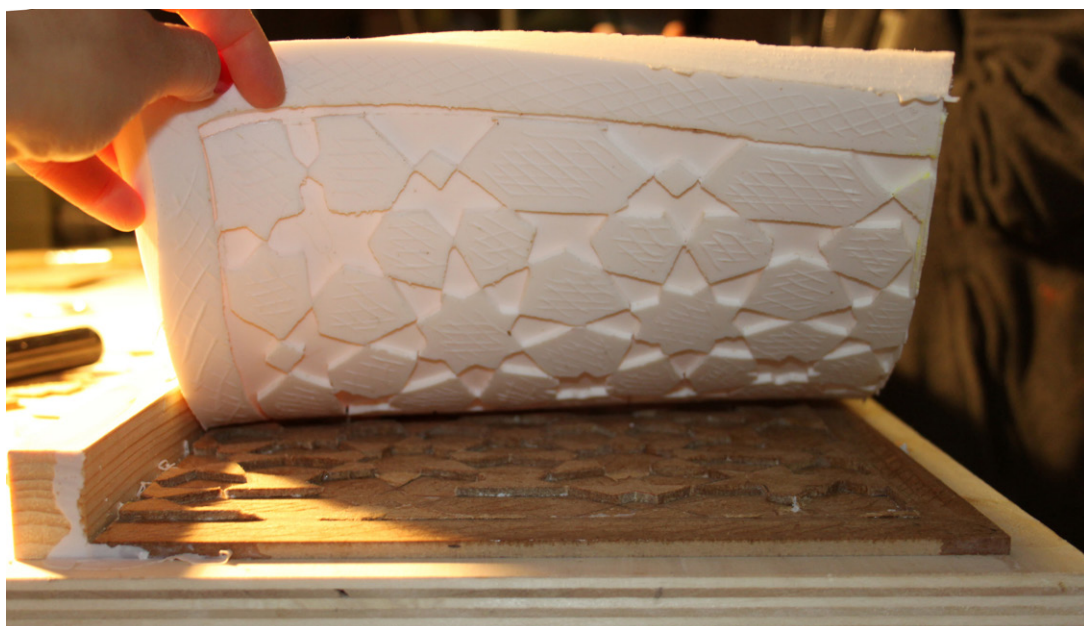
II. 11. © Ártico. Mould. *Report on the conservation and restoration work on the plinth of the Sala de los Reyes. Alhambra (Granada). 2011-2012.*

II. 12. © Ártico. Mould. *Report on the conservation and restoration work on the plinth of the Sala de los Reyes. Alhambra (Granada). 2011-2012.*

In the meantime, theregulatory designs and their deformations were prepared to make the moulds for the stuccoes. For the positives, after studying the work of Rafael Contreras, it was determined that it was necessary to act broadly following the same generative method that he used. It was observed that for the reproductions of the entire surface that had to be replaced, the Contreras team made a total of seven moulds, with different motifs, which, with rotation and inversion systems, were used to make all the reproductions; an eighth mould had to be added for the crenellations.

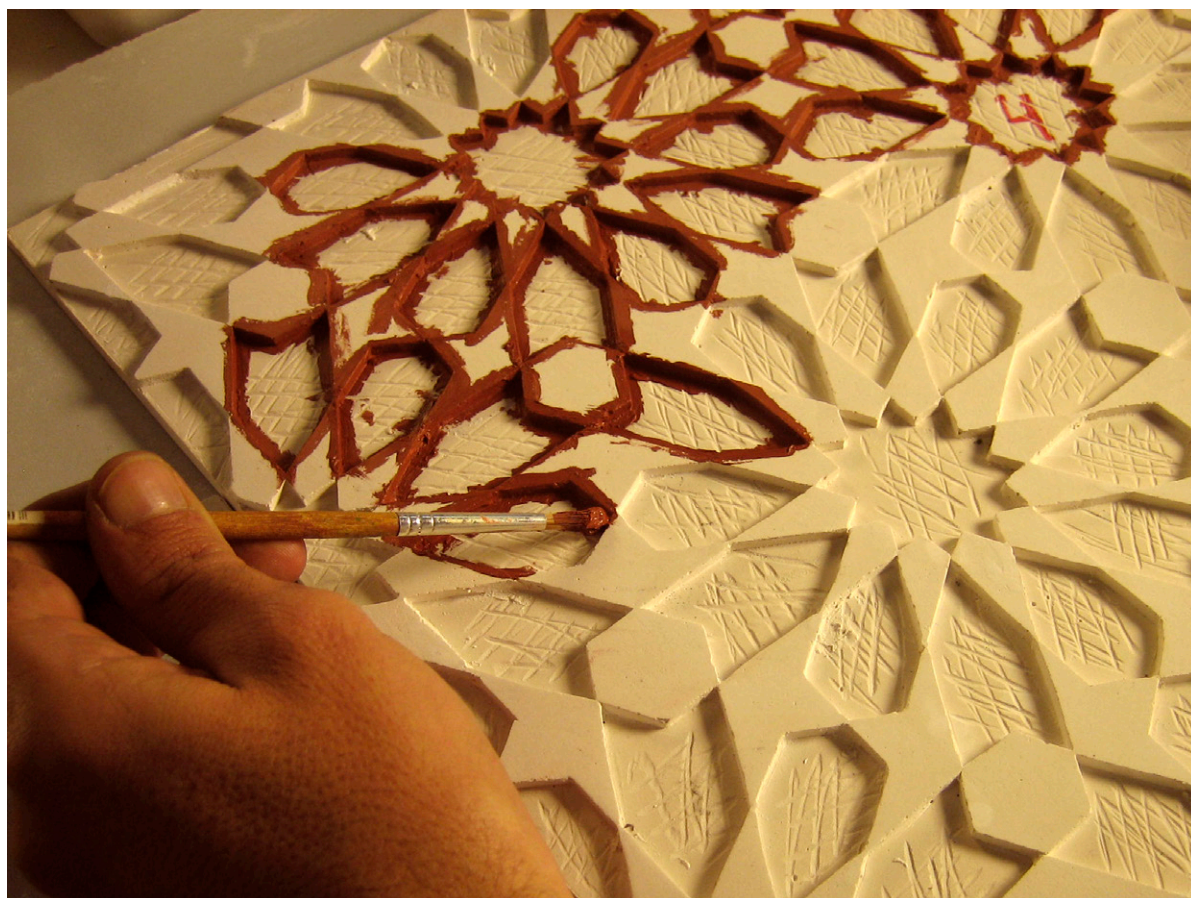
II. 13. © Ártico. Priming of the positive. *Report on the conservation and restoration work on the plinth of the Sala de los Reyes. Alhambra (Granada).* 2011-2012.

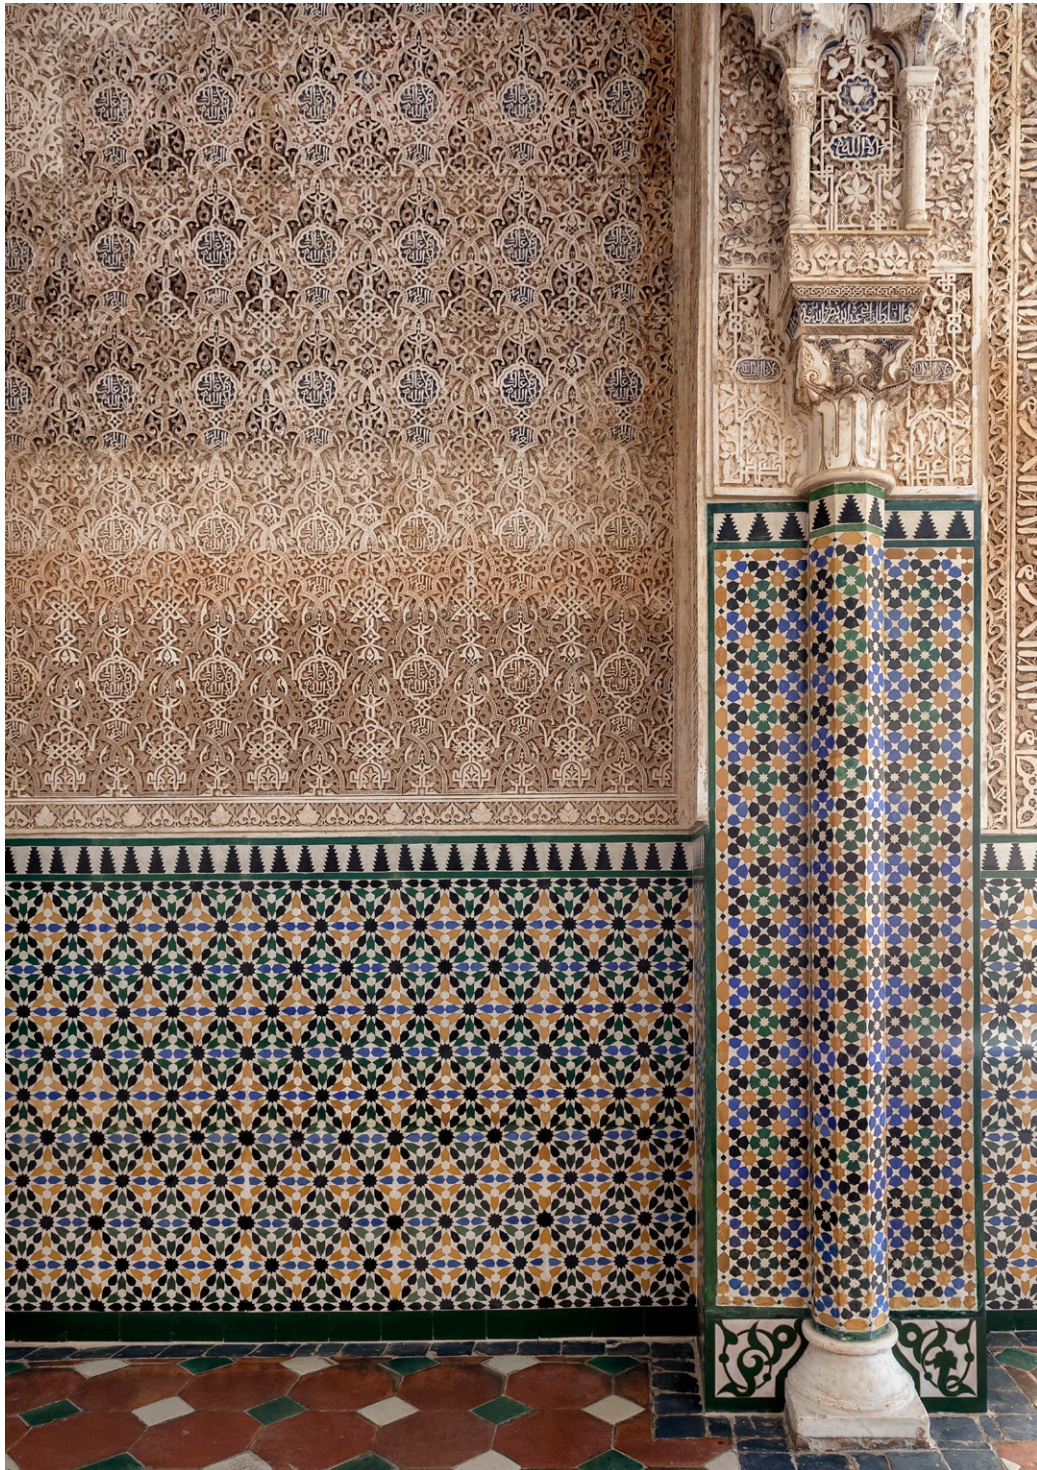
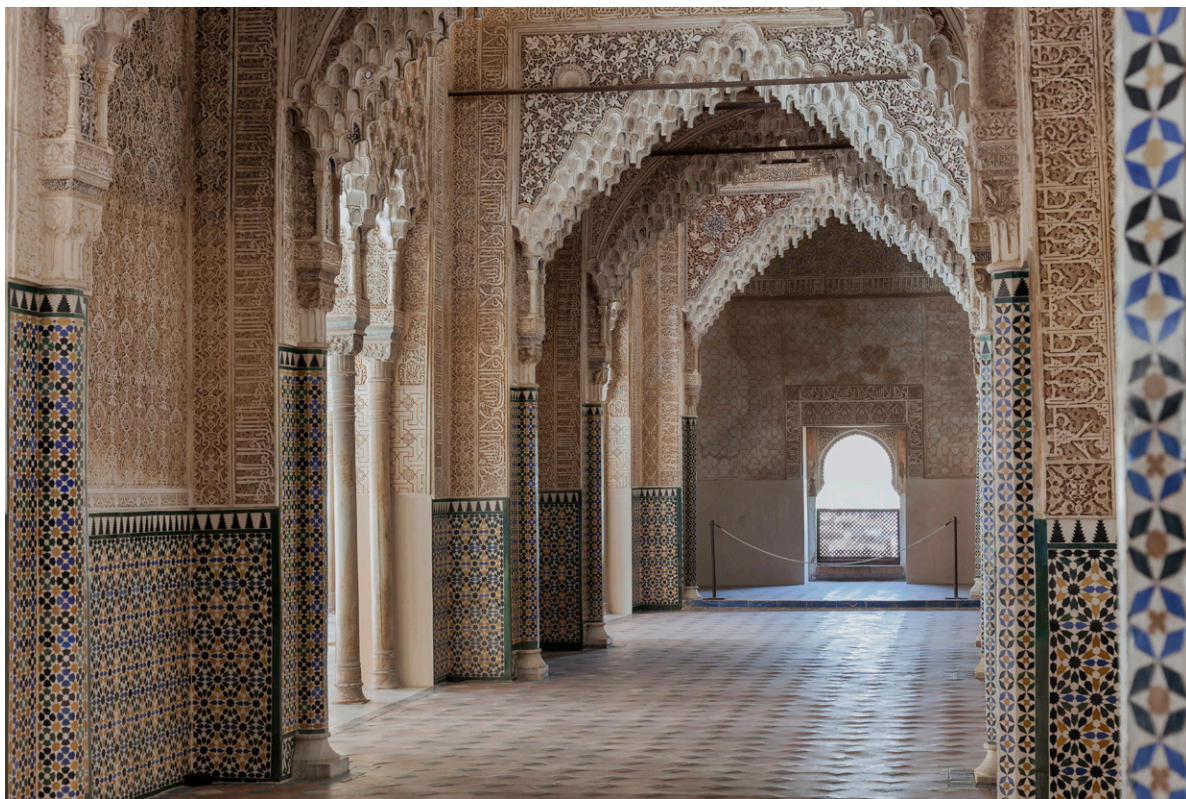
II. 14. © Ártico. Final condition. *Report on the conservation and restoration work on the plinth of the Sala de los Reyes. Alhambra (Granada). 2011-2012.*

II. 15. © Ártico. Final condition. *Report on the conservation and restoration work on the plinth of the Sala de los Reyes. Alhambra (Granada). 2011-2012.*
