THE NASRID MARISTÁN OF GRANADA. RESTORATION OF A MONUMENT AT A DIFFICULT CROSSROADS

PEDRO SALMERÓN ESCOBAR

ABSTRACT: this article considers the consolidation and restoration project of the southern portico of the Maristán. Outstanding historical keys that go beyond the mediaeval period, are provided, and events of the long process that takes place since its incorporation into the public heritage in 1984 until today, are explained. As the recovery of this building is made from remains in very poor conditions, the methodology followed in the project is detailed, and technical solutions that act as a support for a difficult path that interacts with the remains of the original building and makes it understandable as a spatial and functional structure, are described.

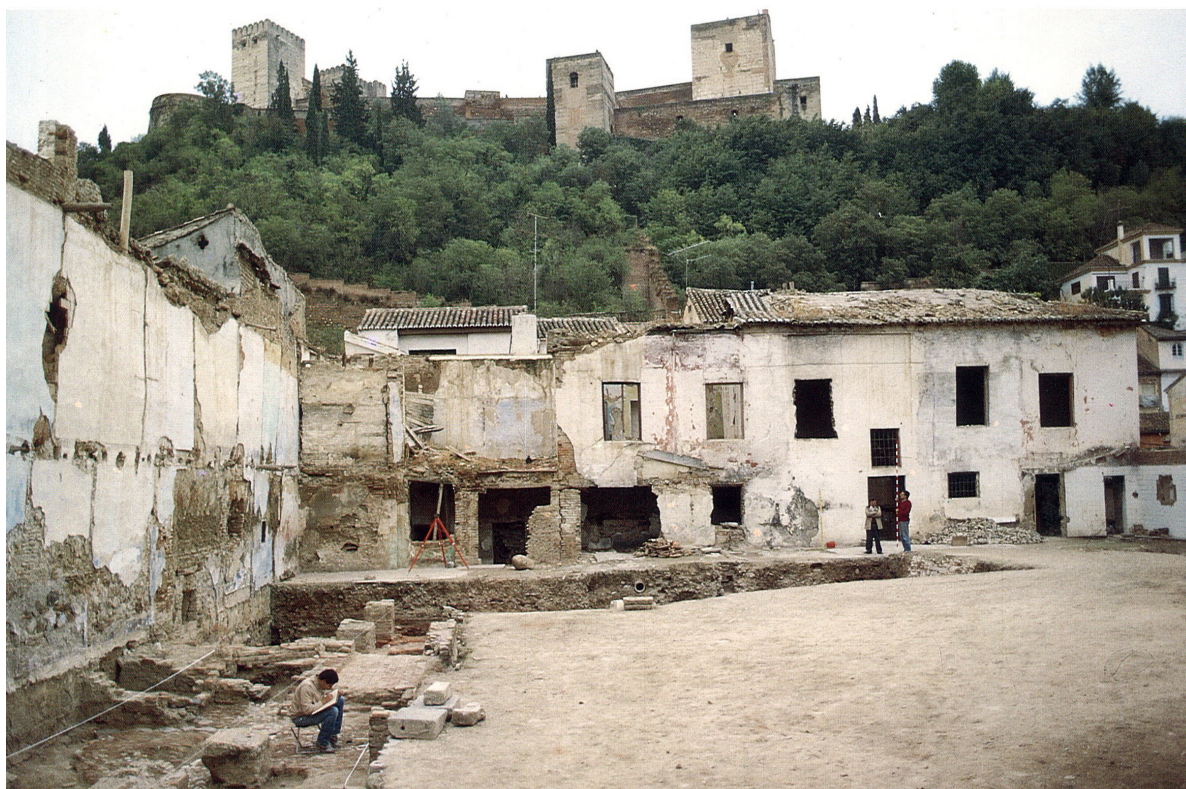
IL. 1. Juan Antonio García Granados. South pavilion, with part of its roof collapsed, once the archaeological excavation of the site and the work to remove debris from the pool had begun (1985).

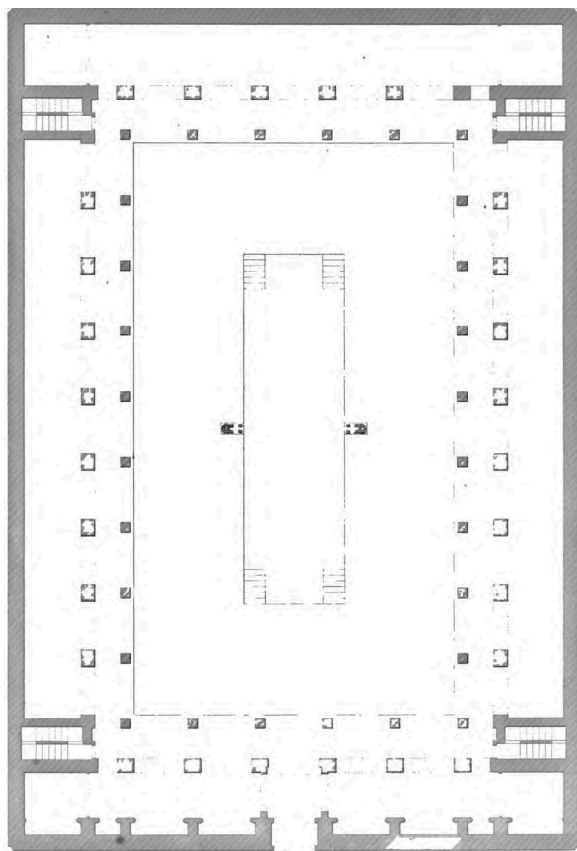
IL. 2. Francisco Enríquez, Floor plan of the Arab Hospital in Granada. In: CLAYE, J (imp.), GIDE (ed.), GAILHABAUD, J (ed. lit.). *Hospital Arabe a Grenade. Plan, T. 3*, n.d. (1858).

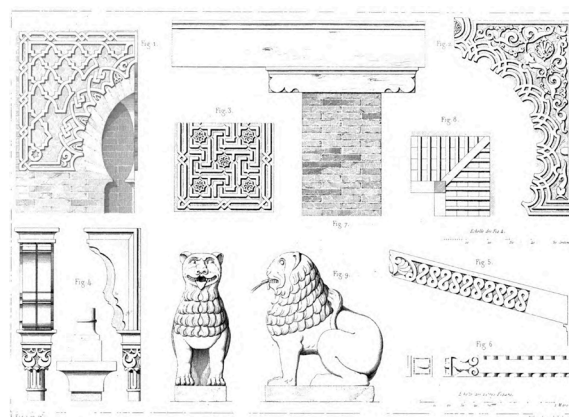
IL. 4. Francisco Enríquez, Façade and drawing of constructive, decorative and sculptural elements. In: CLAYE, J (imp.), GIDE (ed.), GAILHABAUD, J (ed. lit.) *Hospital Arabe a Grenade. Elevation et Coupe longitudinale*, 1858, T. 3, s.p. <https://cutt.ly/lhcASP7>

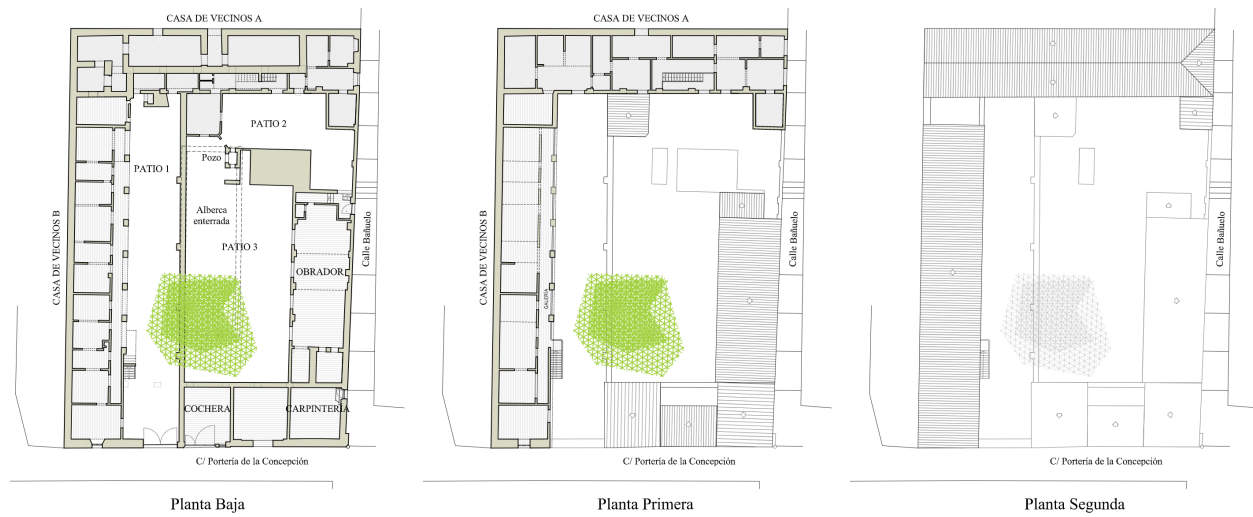
IL. 5. Pedro Salmerón Escobar, Diego Garzón Osuna. Ground floor of the Maristán site, identifying its uses before the 1984 demolition (2019).

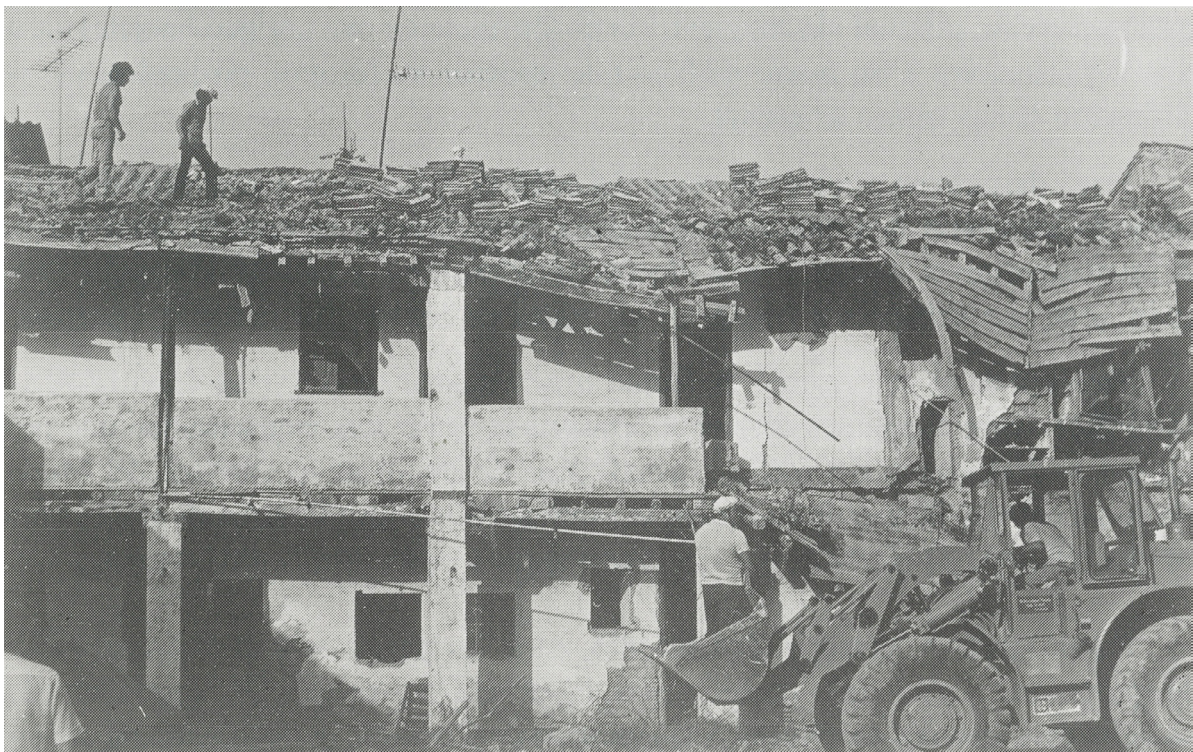
IL. 6. Juan Antonio García Granados, 1984, photo. Demolition of the apartment house that occupied the east bay of the Maristán.

Despite this, the partial demolition of the building (east side) began without impediment. Before the damage was irreparable, the museum made an agreement with the owners to perform the planned excavations; at the same time, debris was being removed and the Andalusian Government was taking steps to acquire the plot²⁴.

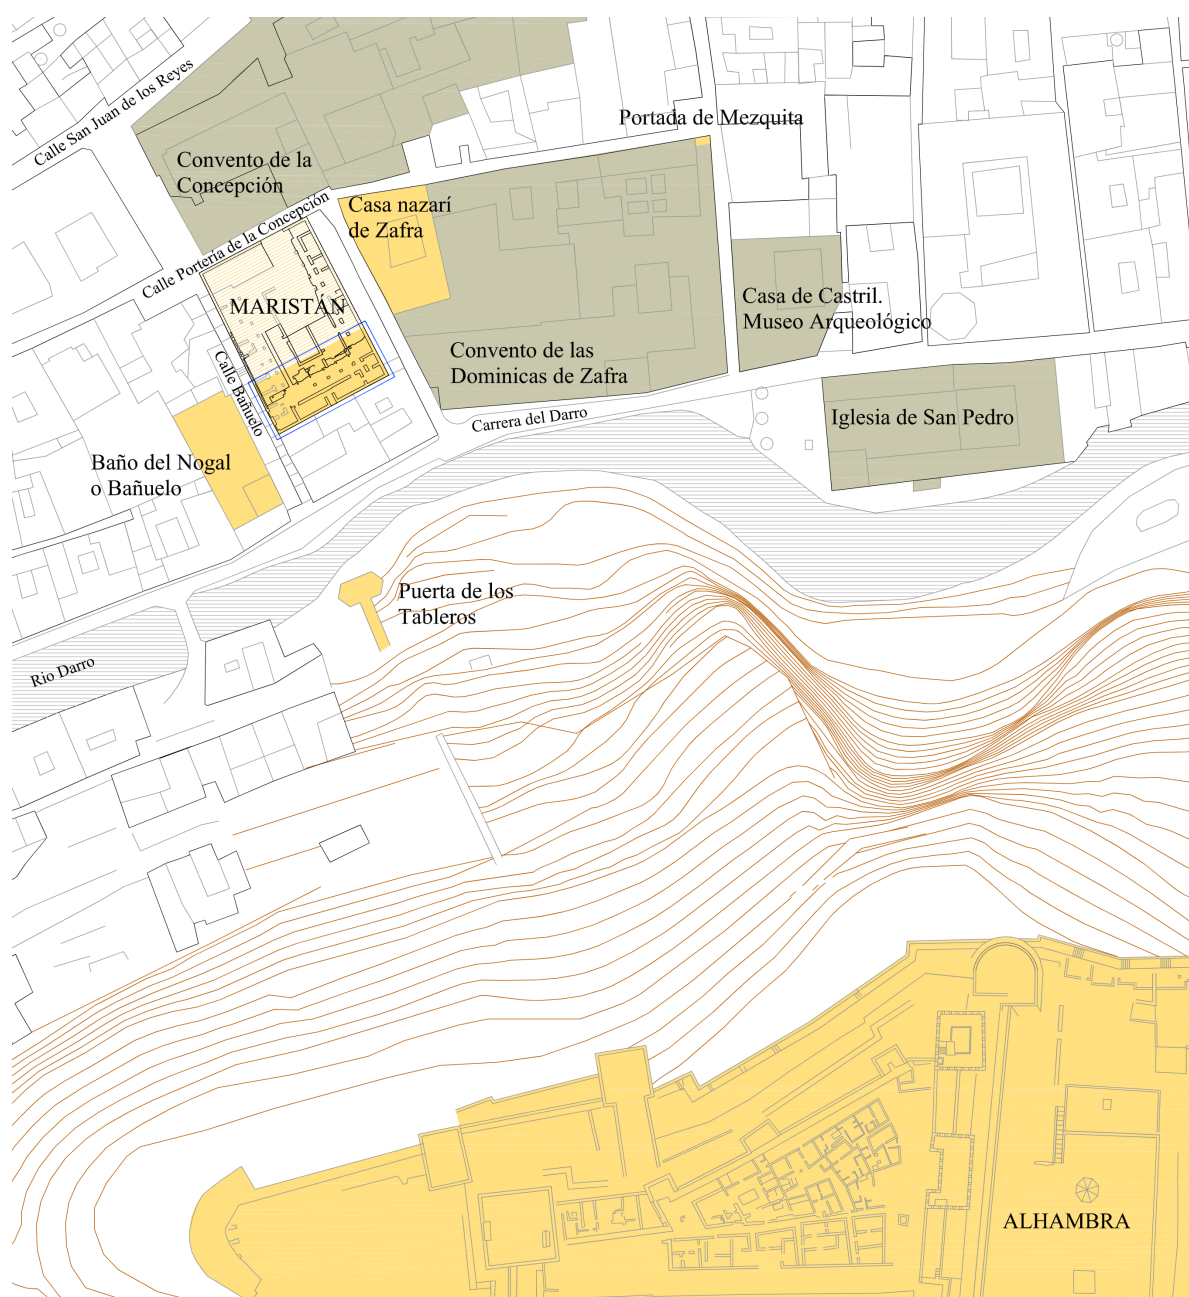
IL. 7. Pedro Salmerón Escobar, Diego Garzón Osuna. Location of the Maristán in the urban plot (2019).

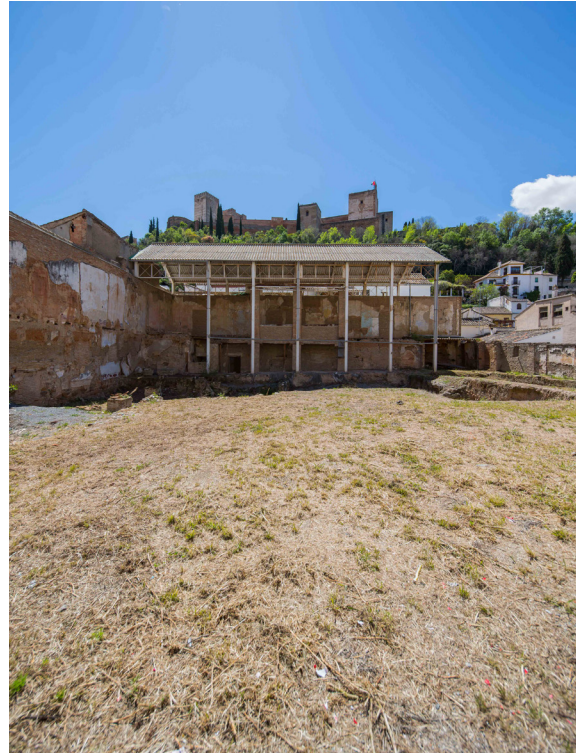
IL. 8. Pepe Marín. General view of the Maristán before the intervention, Board of Trustees of the Alhambra and Generalife (2016).

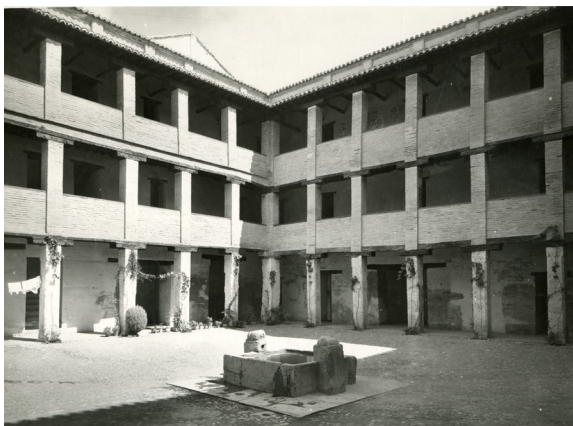
IL. 10. Manuel Torres Molina Granada. Corral del Carbón, patio. Interior view of the patio of the Corral del Carbón, with the water basin in the centre and two floors of arcades (1930-1933?). APAG. Colección de fotografías. F 07298.

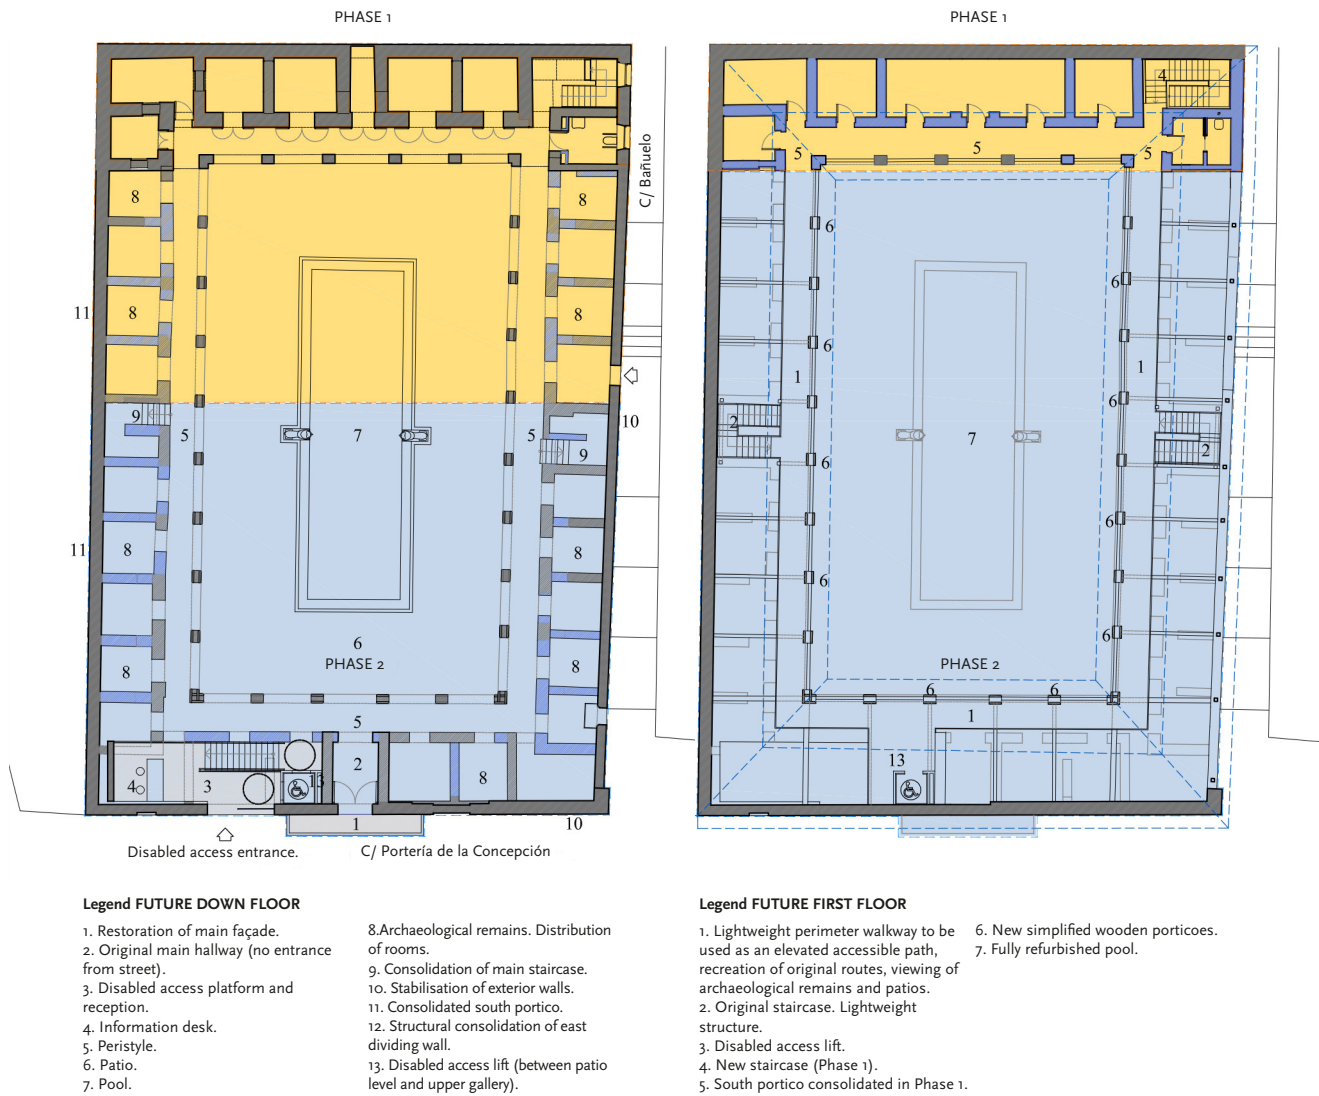
IL. 11. Pedro Salmerón Escobar, Diego Garzón Osuna. Floor plans and perspective of the Maristán, indicating the stages of the intervention (2019).

It has been very difficult to progress towards finding a solution for the Maristán without dividing any intervention into the property into two or more stages. Any attempts to establish a unitary project without distinctions have proved unsatisfactory. The complete reconstruction of the building has run up against legal and methodological problems because a large part of the building is lost. If there is no solid starting base, a false copy of what disappeared could be produced, as Carlo Ceschi explains²⁶,

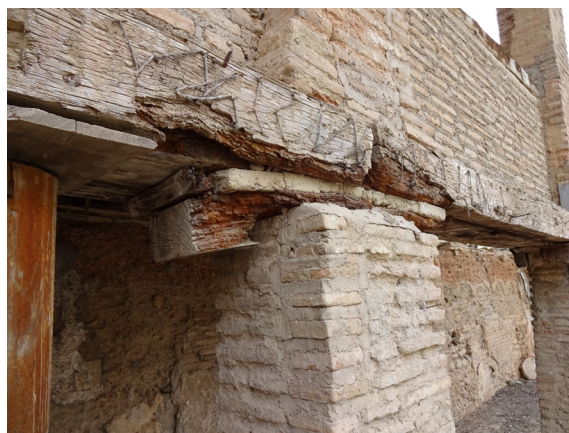
IL. 12. Pedro Salmerón Escobar. Deterioration of south portico footing, lower level (2015).

seismic movement. As a result of this exposure, there has been widespread crushing of the pillar footings and these elements have notably collapsed, while decoupling, rotting and rheological fatigue have appeared in the alfarje parts. This is compounded by the widespread deterioration of the rammed earth walls.

The poor condition of the footings that provide support to the portico's load-bearing walls and battens is the result of their inability to withstand loads, and this in turn is due to extensive biological deterioration from infestations by xylophagous insects and brown rot. The faces of the rammed earth walls reveal widespread loss of the *calicostrado*, a thick layer of mortar rich in fat lime that protected them from the erosive effects of atmospheric agents. Analyses performed in 2018 revealed that the rammed earth walls are of substandard quality with little lime present to act as a resistant, stabilising agent, and insufficient clayey material, these factors all result in very poor cohesion. Consequently, the walls have large disintegrated areas.

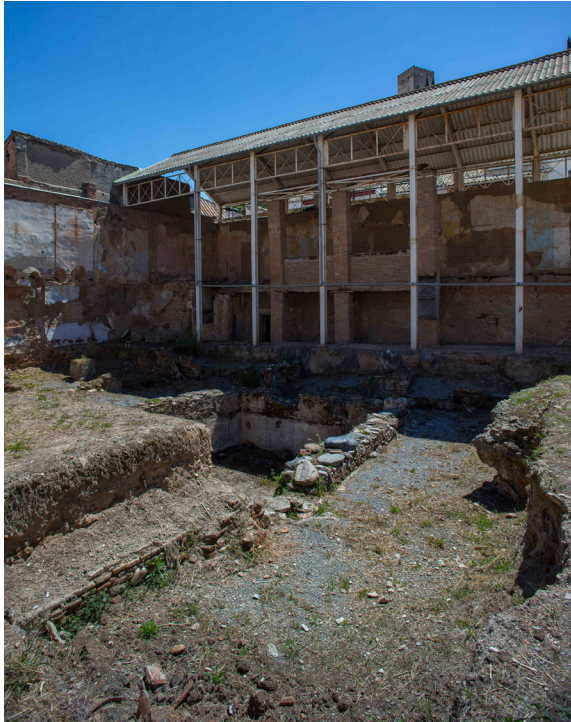
IL. 13. Pepe Marín. View of the pool and south portico before the intervention (2016). APAG.

Recovering the original level of the courtyard will release the columns of the peristyle that are currently half-buried, revealing their full size, which is proportional to the slenderness that can be observed in the upper storey. At the same time, the building work will make it possible to rescue sections of the original paving, integrating them with new pa-

After this first phase, the southern half of the pool will be recognizable. The hydraulic installation that is so closely related to the founding use of the Maristán for welfare purposes should, however, wait for the second phase of the monument's restoration in which its northern half will be excavated and enhanced. This intervention will involve restoring the parapets, basin and floor of the pool, proposing that it be temporarily filled with clean, inert sand and mortar until the second phase is implemented, with a layer of crushed glass as a finish that will evoke a sense of the water it contained as this material plays with the light.

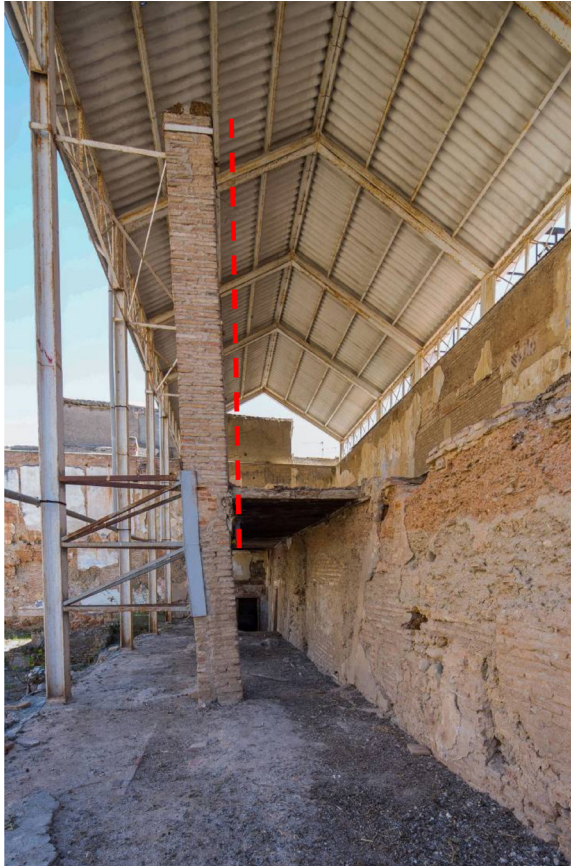
IL. 14. Pepe Marín. Loss of verticality in the south portico pillars (2016). APAG.

The pillars have an evident loss of verticality, especially the three on the first floor. For this reason these elements are joined to each other by a steel prosthesis added to the metal structure that has protected the remains for the last 30 years. The main reason dismantling the pillars is essential is the need to eliminate this auxiliary structure as a first step before excavating and removing the filling that covers the ground floor of the Maristán, thereby making the restoration of its volume possible. This task should be performed by dividing the pillars into drums that are confined with a strong casing that allows the pillars to be dismantled into 70 cm-high packages using a small hydraulic crane. By making an inventory of these elements under the supervision of a restorer, cleaning cement mortar overlays, the surfaces of joints and eliminating any unnecessary caulking, they can then be replaced in sections, using base planes with elastic mortar made from natural hydraulic lime. Once the drums that each brick pillar has been divided into have been relocated on the ground floor, the plan is to work on the gallery's alfarje ceiling after fitting restored footings and new wooden lintels. This solution will also be used on the upper floor.

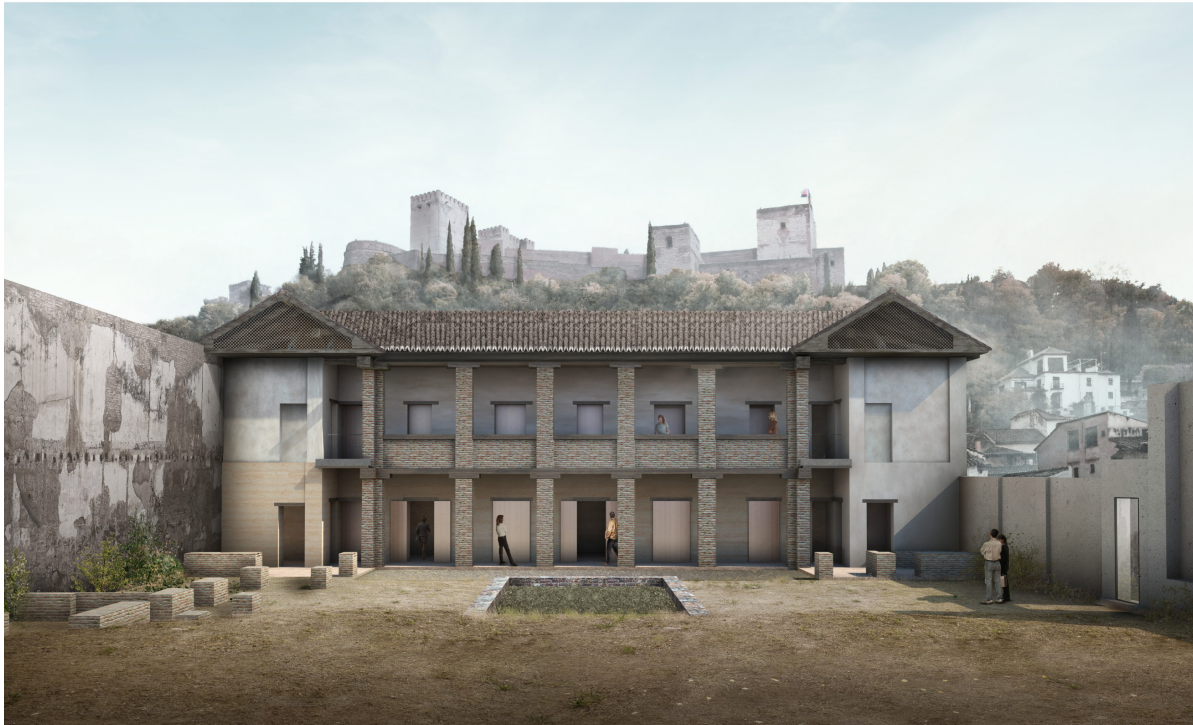
IL. 18. Pedro Salmerón Escobar, Lucía Balboa Quesada, Antonio Jiménez Quesada. Infographic. 3D image of the restored south pavilion (2019).

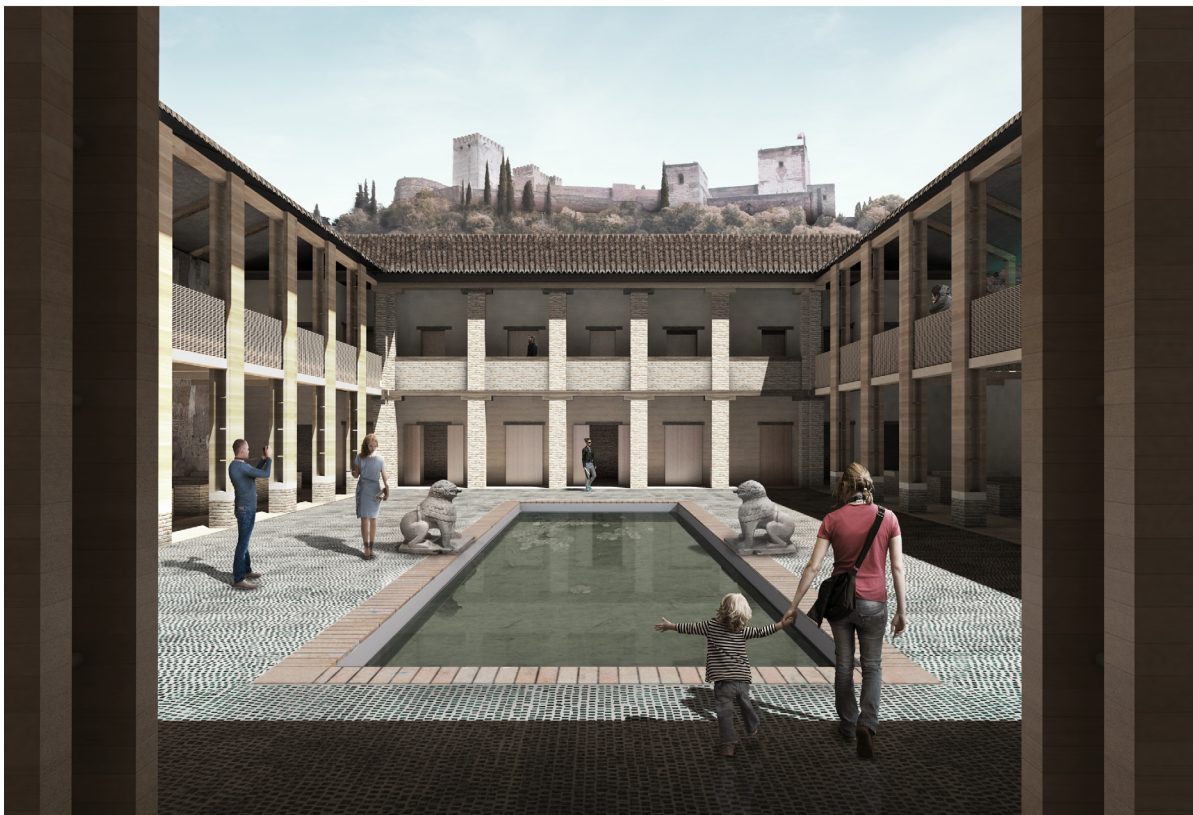
IL. 19. Pedro Salmerón Escobar, Lucía Balboa Quesada, Antonio Jiménez Quesada, infographic. 3D image. Central view of the restored Maristán in stage two (2019).

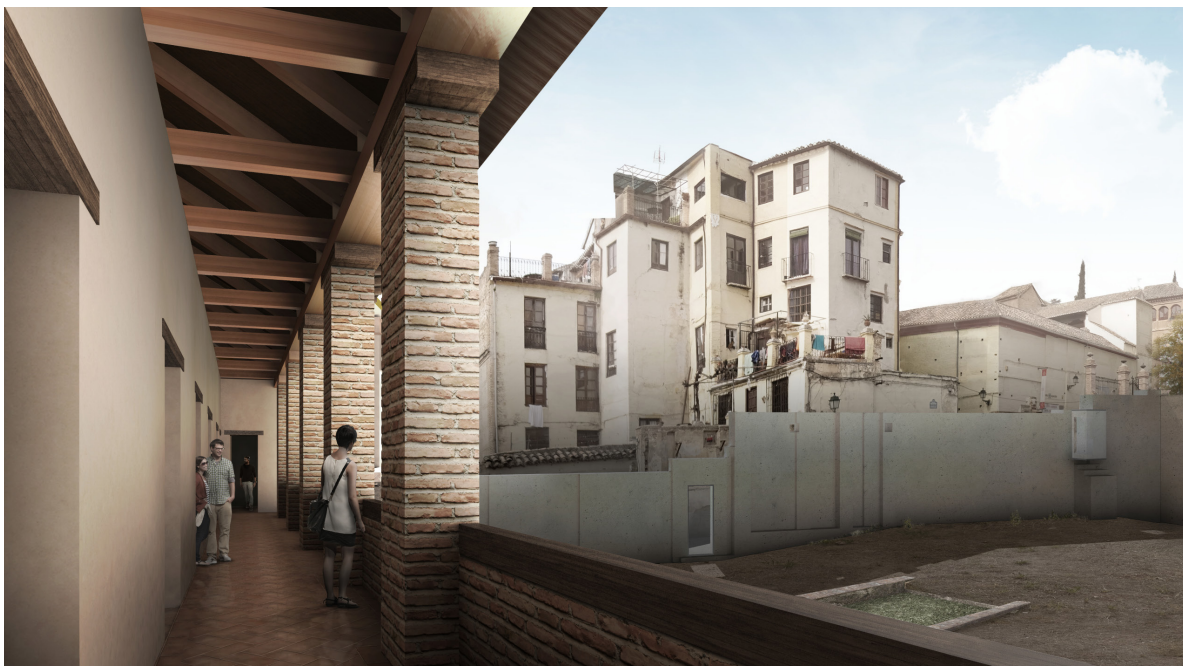
IL. 20. Pedro Salmerón Escobar, Lucía Balboa Quesada, Antonio Jiménez Quesada, infographic.
3D image of a detailed view of the south pavilion (2019).

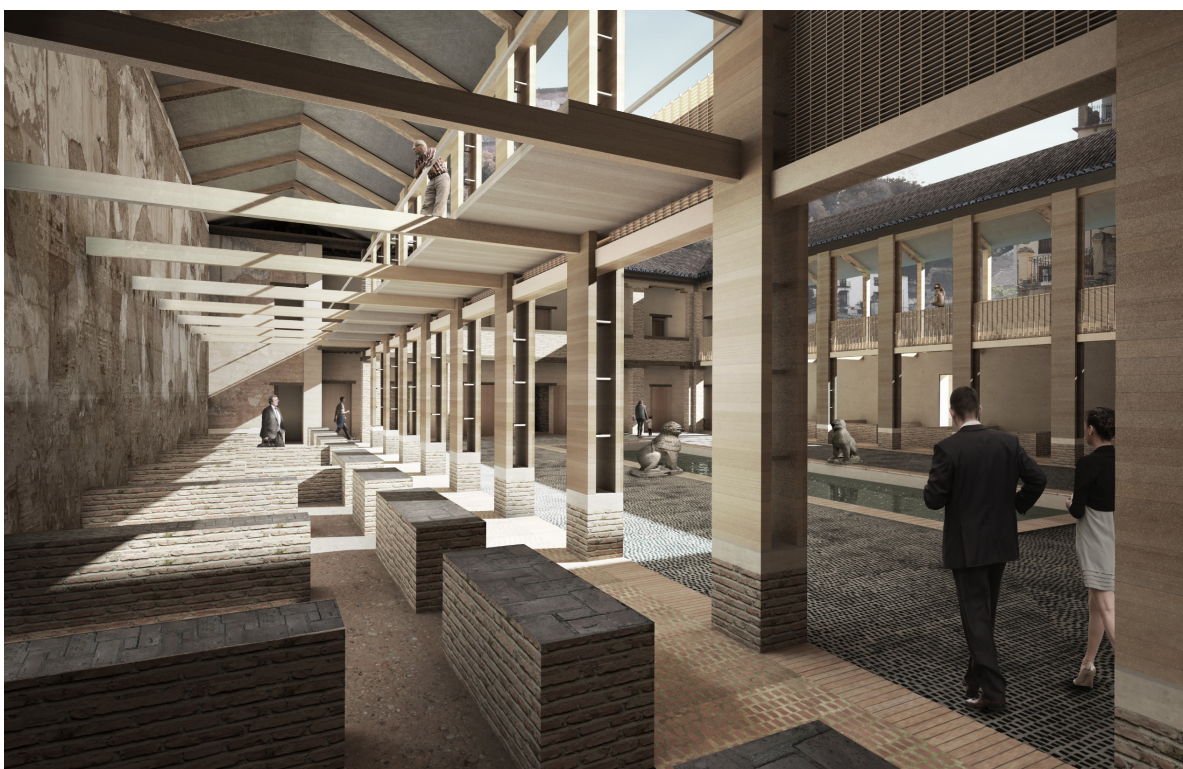
IL. 21 Pedro Salmerón Escobar, Lucía Balboa Quesada, Antonio Jiménez Quesada, infographic.
3D image. Oblique view of the restored Maristán in stage two (2019).
