THE RESTORATION OF THE PAINTINGS ON LEATHER IN THE HALL OF THE KINGS OF THE ALHAMBRA

ELENA CORREA GÓMEZ

RAMÓN FRANCISCO RUBIO DOMENE

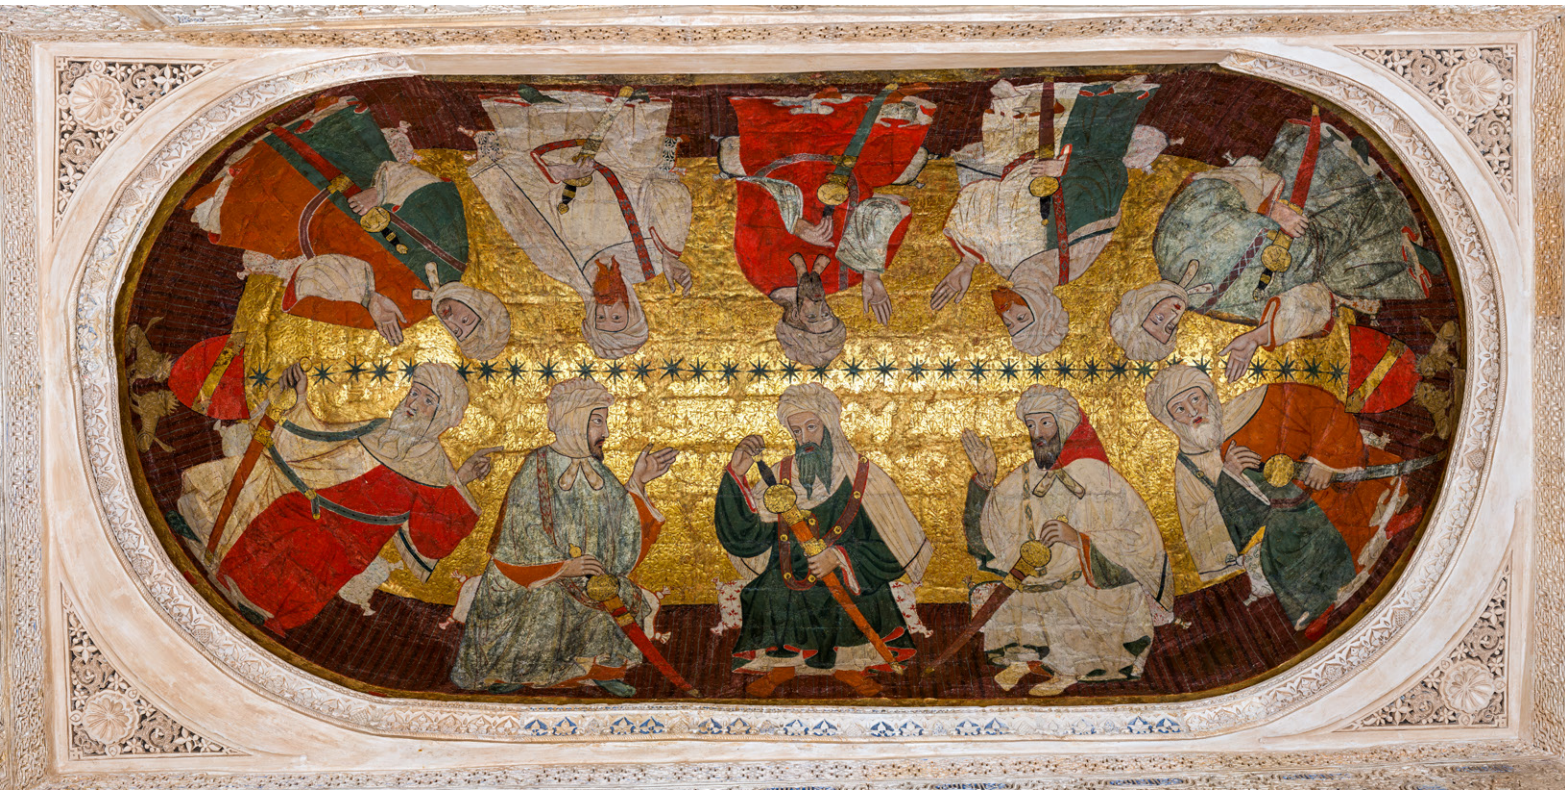
II.1 Final state of the central vault after its restoration. Ten people are seated on cushions on a dais with a gilt background, an imitation of damask as a sign of the wealth and opulence of the figures. The scene has been interpreted in various ways: as kings belonging to the Nasrid dynasty, a meeting of high dignitaries with the sovereign Muhammed V, an Arab council or mexuar, tribal chiefs from Granada, nobles being invested with the Order of the Band or a court in deliberation. Amadeo López del Águila, Paintings on leather in the side alcoves of the Hall of the Kings in the Alhambra, Granada. Central alcove, 2019, Alhambra and Generalife Board of Trustees, Archive.

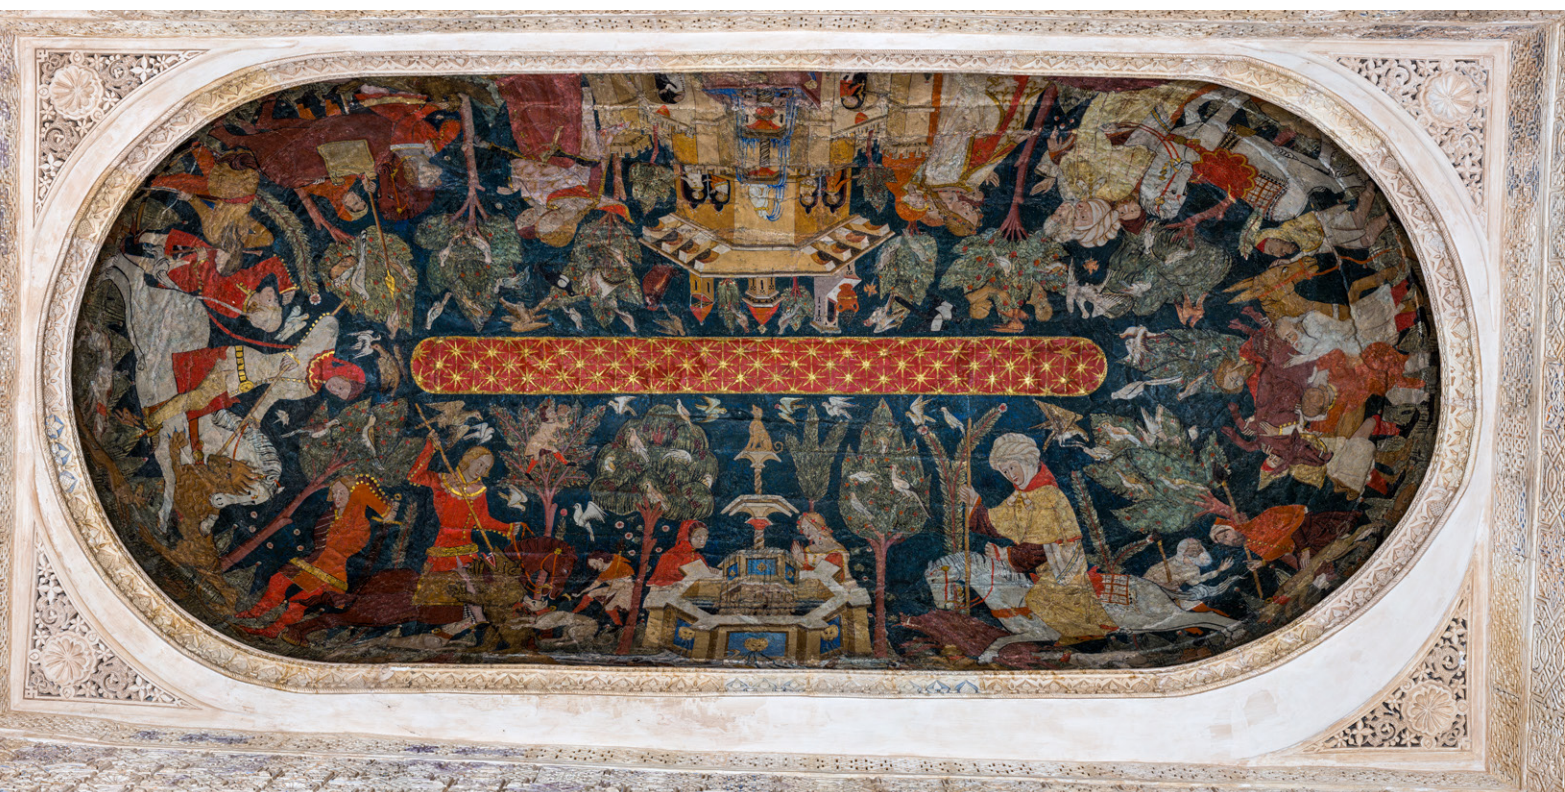
II.2 Final state of the north vault after restoration: hunting scenes are set against a starry background with “the castle of love” and “the fountain of youth” as a transversal axis. The Fountain of Life or Fountain of Eternal Youth is a classic allegorical theme in which the characters preserve the body's vigour or regain their youth after bathing in its waters. Amadeo López del Águila, Paintings on leather in the side alcoves of the Hall of the Kings in the Alhambra in Granada. North alcove, 2019, Alhambra and Generalife Board of Trustees, Archive.

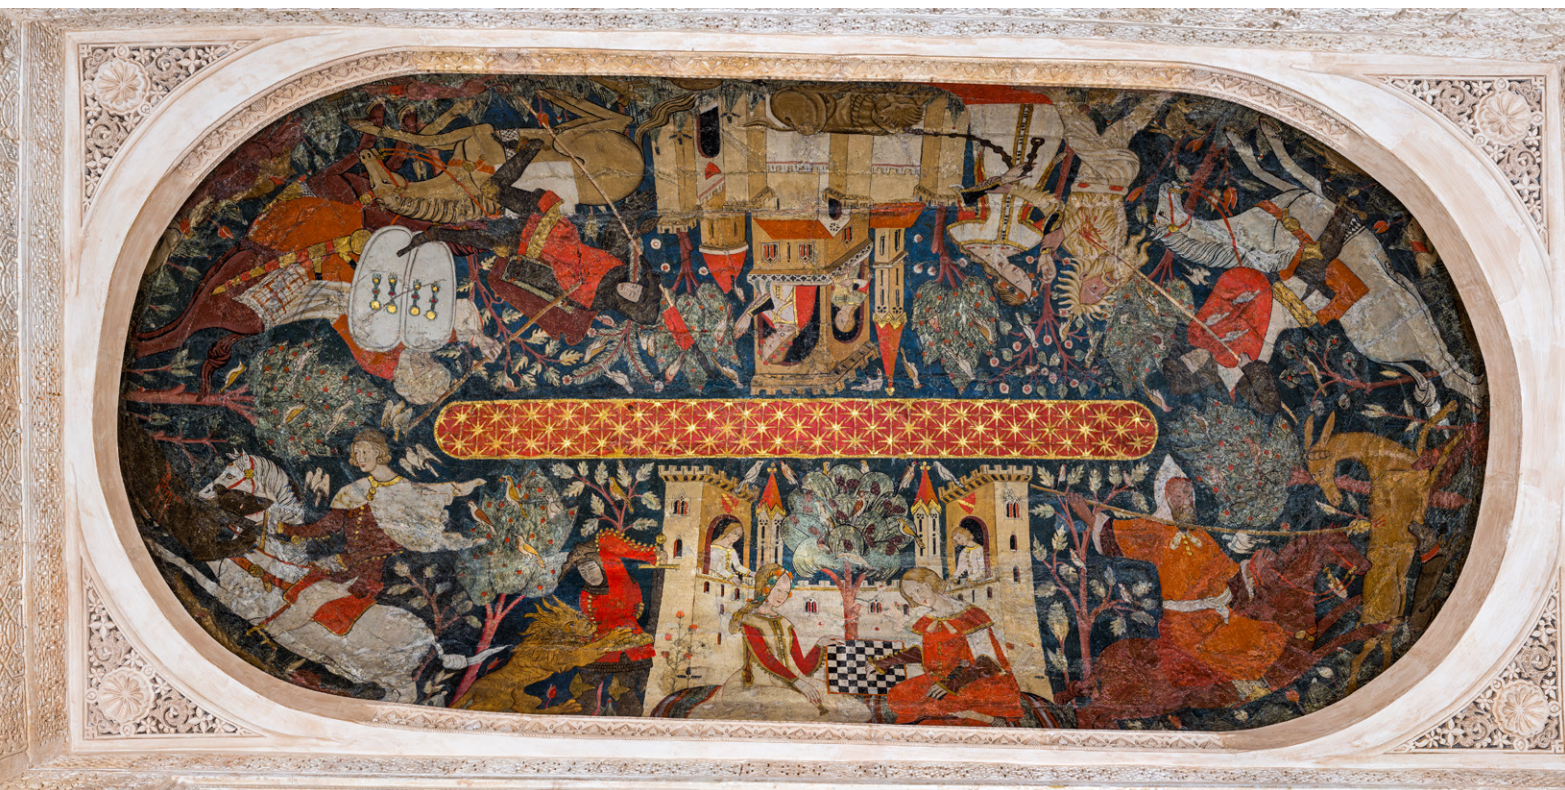
II.3 Final state of the south vault after restoration: the scene of the "lady playing chess" is at the centre of the composition, together with the rest of the hunting and fighting scenes. The game of chess was introduced in Al-Andalus in the 9th century; the board is shown vertically as in the Book of Games of Alfonso X and on this occasion the game is being played without pieces. Amadeo López del Águila, Paintings on leather in the side alcoves of the Hall of the Kings in the Alhambra in Granada. South alcove, 2019, Alhambra and Generalife Board of Trustees, Archive.

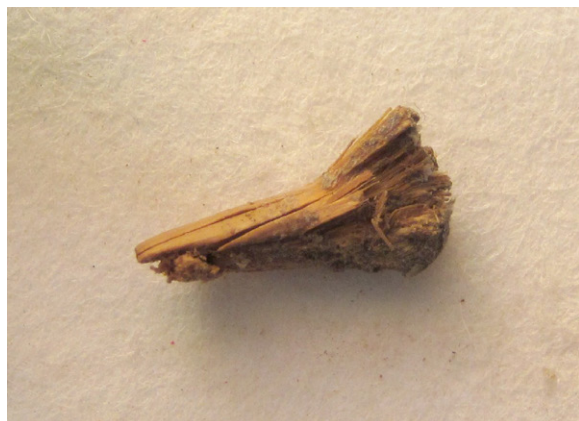
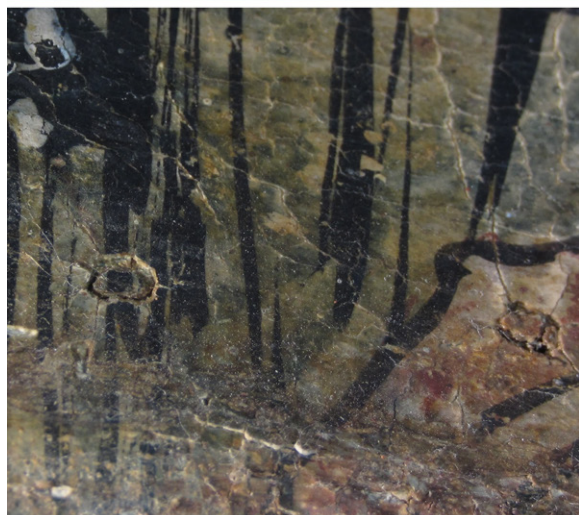
II.4 View of one of the 9-mm-long bamboo pegs detached during the restoration process. Below this image, the circular alterations produced in the pictorial layer by this system of anchoring the leather to the wooden structure can be seen. Cruz Ramos Martínez, Bamboo peg; Alteration-Location bamboo pegs through the painting, 2015, Alhambra and Generalife Board of Trustees, Archive.

Contreras who nailed the edges of the leathers with iron nails to replace the detached cane pegs²².

The report on the work presented by the Commission of Artistic Monuments of the Province of Granada in 1871 states how the fragments that had become detached or were about to become detached were fitted and “their edges were secured with small metal nails, and the resulting cracks plastered”²³.

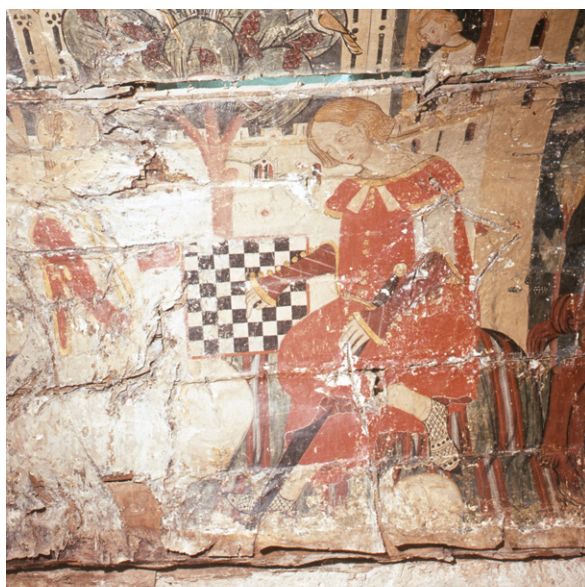
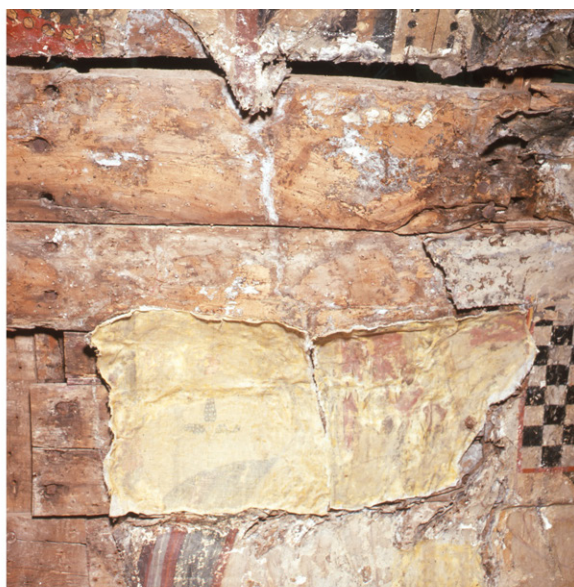
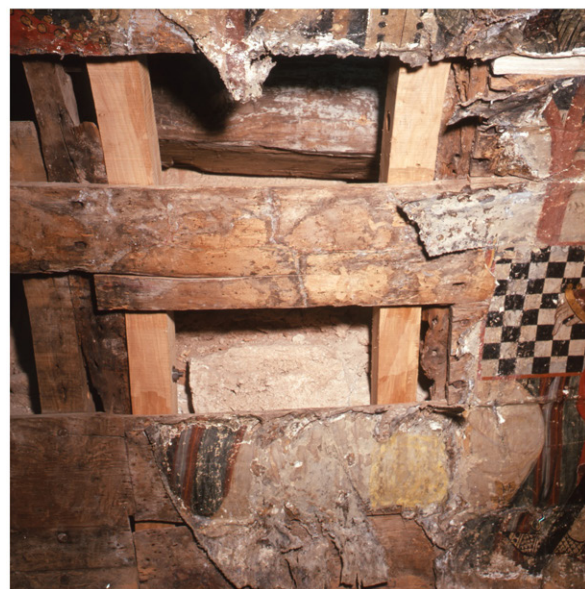
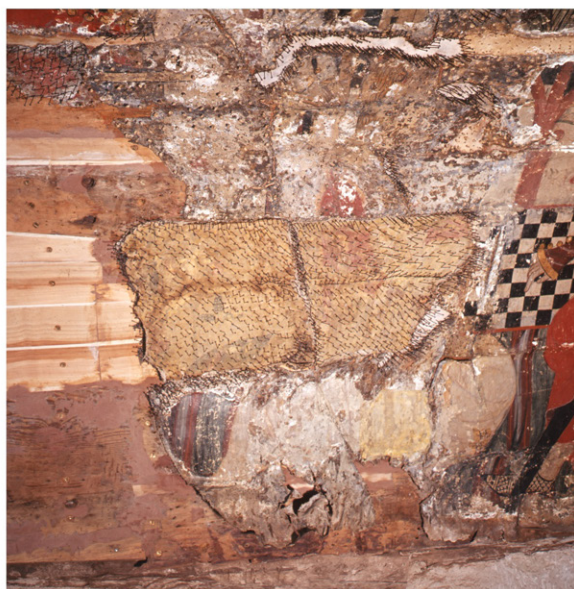
II.5 View of the restoration work by Juan Santos Ramos, in which part of the floorboards of the south vault have been replaced. The leathers in better condition and with traces of paint were softened and tightened by temporary pins and new bamboo pegs after drying. Choin, Vault restoration processes "The Lady Playing Chess", 1980, colour slide 6x6 cm, Alhambra and Generalife Board of Trustees, Archive.

In 1980 work began on the restoration of the area most affected by the leak in the vault of the Lady Playing Chess: the stains of the wax plaster were removed, a large number of iron and brass nails were extracted, certain areas were crimped, some fragments of leather held in place by nails were loosened, and the wood was stripped from the back of the vault to remove the leather. The Alhambra carpenter Antonio Soria Fernández replaced part of the wooden structure in this area affected by rotting fungi: boards were fastened to reduce the unevenness with screws and new maricao wood sides and planks were put in place, interspersed with balsa wood strips in the joints where it was deemed appropriate. Epoxy wood paste (Araldit) was also used to bridge unevenness and convexities. At the same time, old glue residues were removed and

the best preserved leathers were softened and stretched, as it was considered better to discard leather that was too rotten and had no paint residues. New tanned goatskins were used in their place, which were glued wet and temporarily pinned in place. After drying, the pins were replaced with specially made cane cuttings (Il. 5). After this operation, the protrusions of the pegs were shaved off and a coat of rabbit glue was applied before the animal glue was applied, followed by colour reintegration with rigatine tempera and fine mordant gold for the gilded decorations. The protective coatings were removed and the wax was removed from each area³¹.

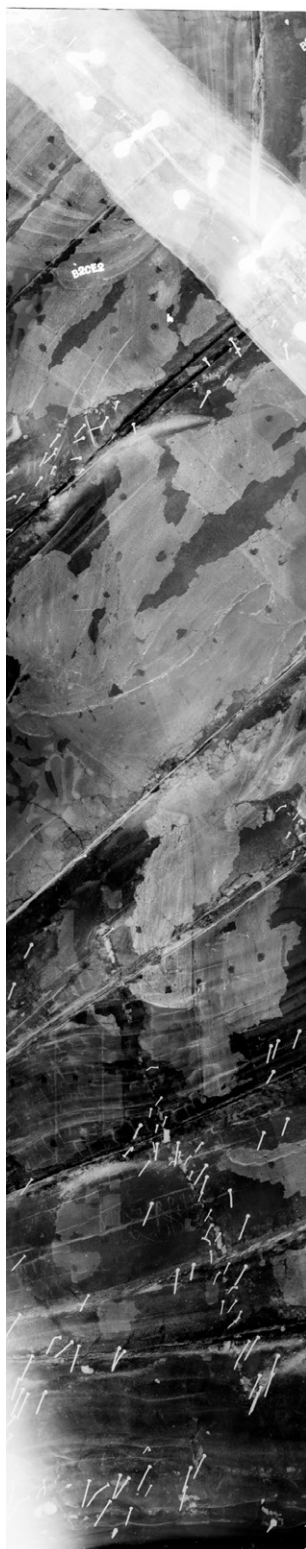
II.6 Digitised image of a radiographic plate of the central vault. X-rays have provided valuable information on the wooden structure and the pictorial ensemble. They show the size of the boards and distinguish between maricao and pine wood (with much more visible grain), the type of metal elements used in their construction, the areas affected by cubic rot, the size of the leathers, their faults and seams. As for the pictorial layers, we can distinguish the preparatory incised drawings, the initial bamboo pegs, the original paint delimitation, the superimposition of wax stucco and all the nails or metal points used in later interventions. Applus, X-ray B2CE2-4, 2010, radiographic plate, Alhambra and Generalife Board of Trustees, Archive.

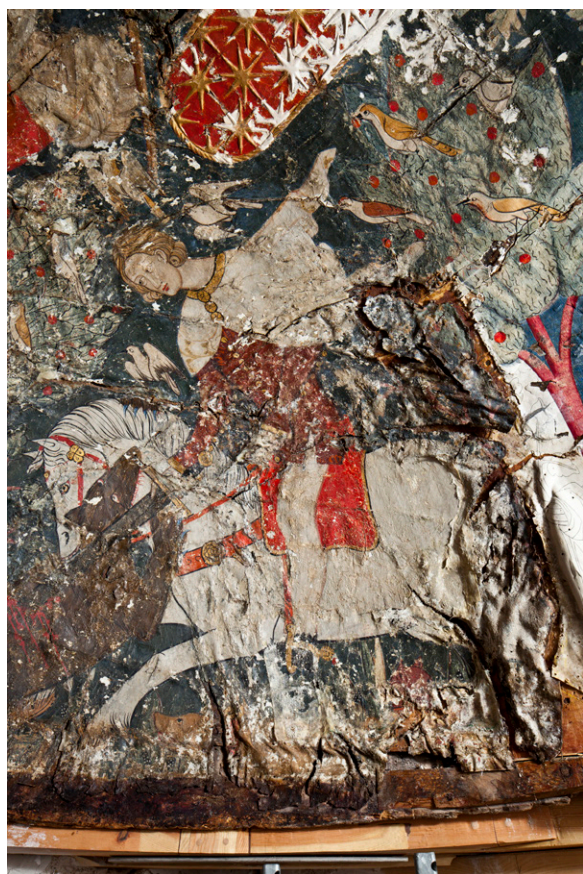
II.7 Bear hunting scene from the south vault illuminated with tangential light, showing the characteristic pathologies of the leather: deformations, hardening, folds, loss of attachment to the wooden support, darkening and stains caused by the oxidation of adhesives, breakage of stitching and of the leather at the joints of the planking, attachment of the leather using metal pins, addition of new fragments of leather, etc. Amadeo López del Águila, PINTURAS_SRR_BOVEDA1-042, 2012, Alhambra and Generalife Board of Trustees, Archive.

Separation of the leather support from the wooden structure has occurred due to the continuous movements and dimensional variations caused by the absorption and desorption of water from said materials. The movement of the wooden planking and the leather itself has led to tears and rips in the leather covering and the seams. There are missing parts in the leather support of different sizes and shapes due to the loss of larger pieces or small fragments (II.7).

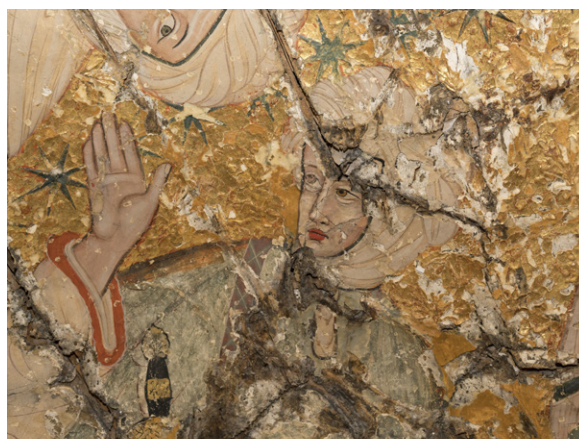
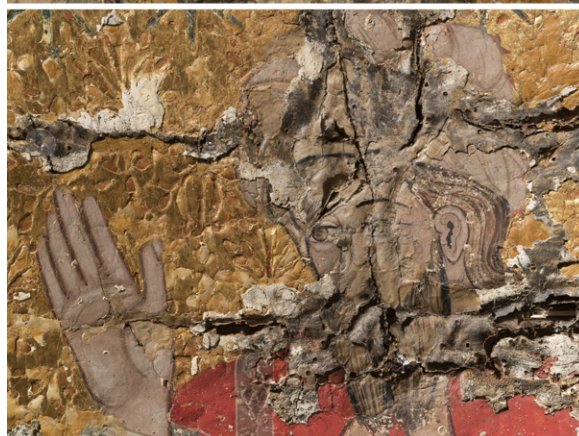
II.8 Characters in the central vault on the gilded background, an image that brings together the main pathologies of the pictorial layer. The ruptures and deformations suffered by the leather have been transmitted to the coloured layers and have caused cracking, lifting, peeling and loss. The image was taken after partial removal of the wax stucco. Eduardo Mendoza, untitled, 2018, Alhambra and Generalife Board of Trustees, Archive.

In general, cracks and fissures can be observed, usually coinciding with the joints between the wood and leather pieces, craquelure, flaking or bubbling, small missing parts that expose the original preparation, and large missing parts (II.8).

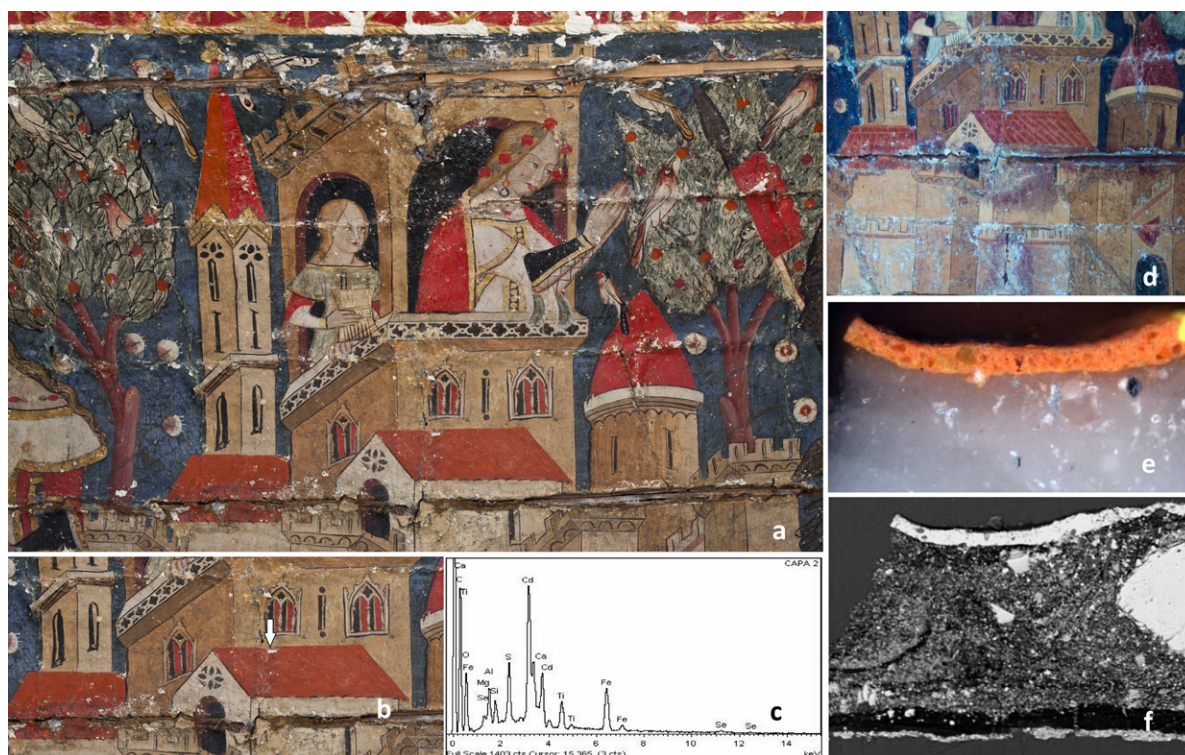
II.9. a: Scene belonging to the south vault with red repainting on the lower roofs; b: point of extraction of the samples; c: result of the EDX microanalysis of layer 2; d: illumination with ultraviolet light of the scene in which the pattern of the tiles can be made out, barely perceptible when illuminated with visible light. The study of paintings with fluorescence induced by ultraviolet light can provide information on the technique and state of alterations and interventions not inherent to the work. The fluorescence of the paints is determined by the type of binder, the pigment and the combination of both. Most of the pigments have a very slight fluorescence, except for zinc white, cadmium yellow and cadmium red, among others, characterised by strong fluorescence; e: 200X petrographic microscope image of the stratigraphic section showing layer 1 of whitish preparation thicker than 475 μm , composed of calcium carbonate, dolomite, silicates and silica grains, and layer 2 of a thickness of between 30 and 50 μm of orange-red colour formed by cadmium red, cadmium yellow, ochre earth and titanium white; f: scanning electron microscope image (with BSE detector) of the cross-section. a and b: Amadeo López del Águila, PINTURAS_SRR_BOVEDA1-205, 2012, Alhambra and Generalife Board of Trustees, Archive; c: Eugenio Fernández Ruiz, 14PROY-01-P1-003, 2012, Alhambra and Generalife Board of Trustees, Archive.

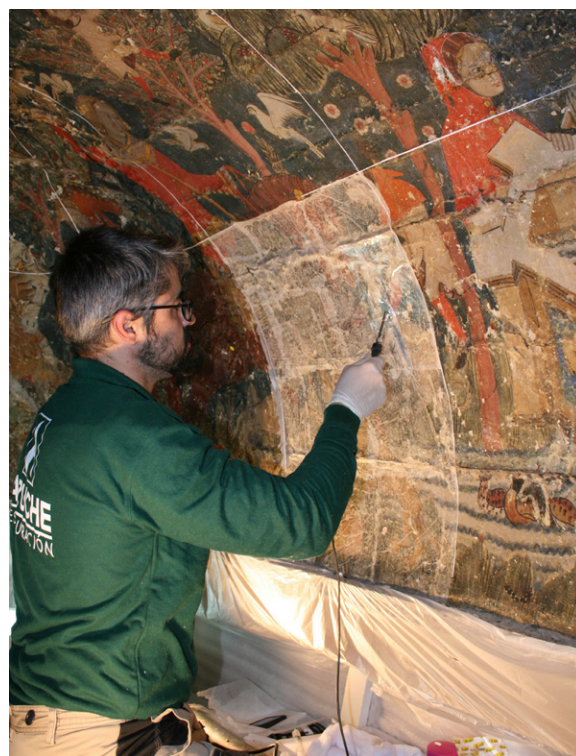
Il.10 Colour application process in the north vault "The Fountain of Youth". The adhesive was applied by injection under the scales or through Japanese paper. Moderate heat was applied to achieve greater penetration. Azuche 88, untitled, 2014, Alhambra and Generalife Board of Trustees, Archive.

the paint, a general colour was re-applied using the same type of resins and moderate heat (Il. 10).

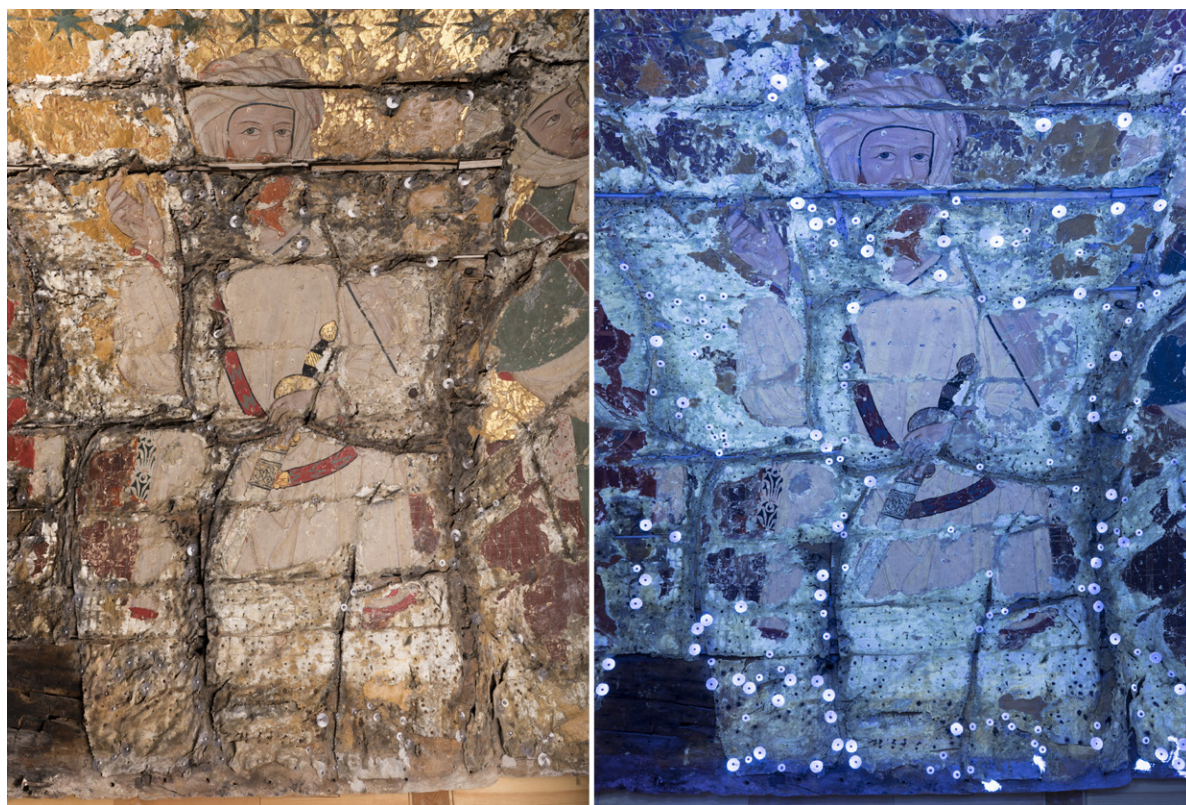
II.11 Mechanical anchorage points of the leather to the wooden structure in a central-vault character illuminated with normal and ultraviolet light. The ultraviolet light or black light reveals all the anchorage points used. Eduardo Mendoza, untitled, 2018, Alhambra and Generalife Board of Trustees, Archive.

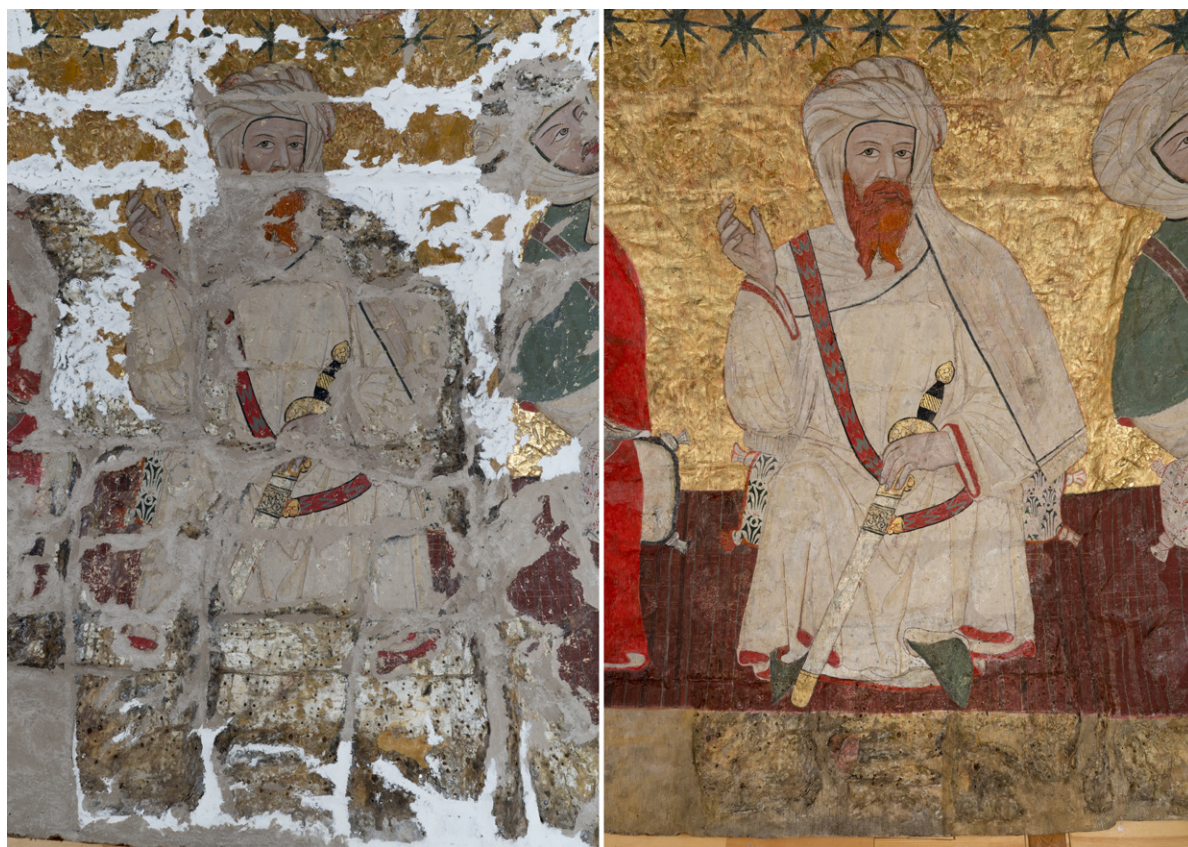
II.12 Volumetric reintegration of the figure in II. 11 with cellulose stucco. The stucco has been mass-coloured to facilitate the process of chromatic integration, except for the gilding, which has been used without colour. In terms of texture, the surface of the stucco has been left slightly uneven to encourage a certain vibration of the reintegrated areas. For the chromatic reintegration of the gold areas with relief, the cellulose stucco was applied smooth and a template was used for the rigatine tempera, adding shading that imitated the volume. It has also been necessary to colour-correct washers, metal fasteners, old wax stuccoes and replaced leathers. Eduardo Mendoza, untitled, 2018, Alhambra and Generalife Board of Trustees, Archive.

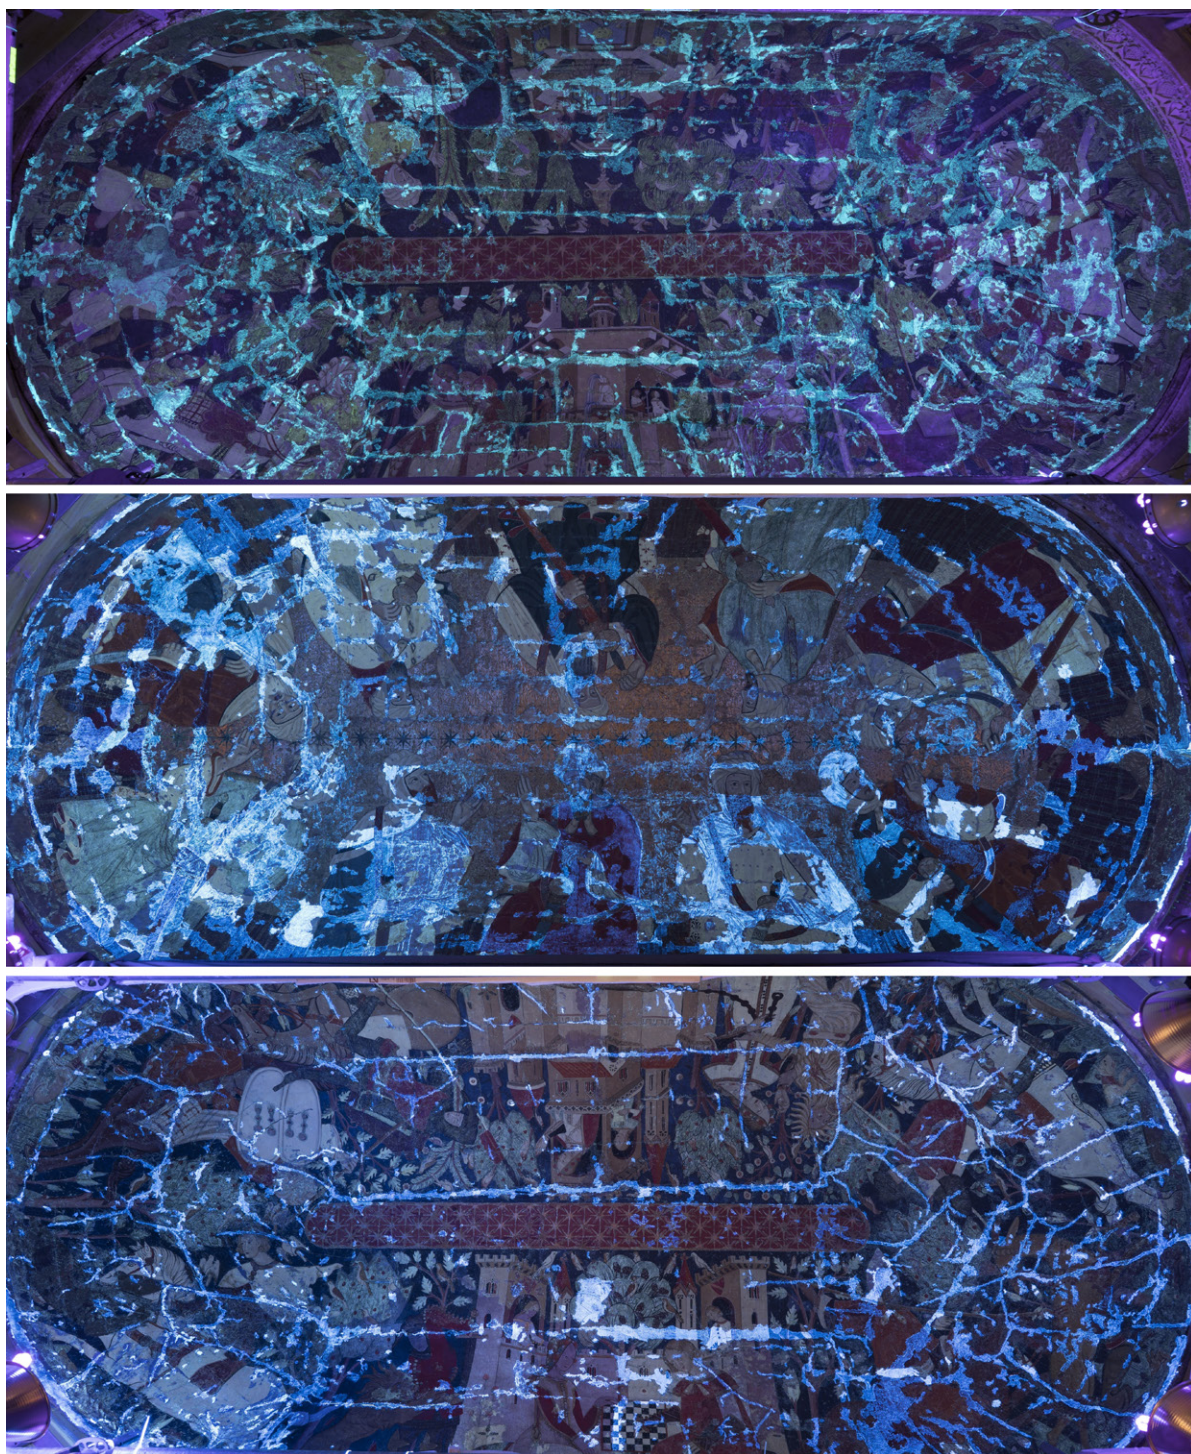
II.13 Images of the vaults after the chromatic reintegration processes and illuminated with ultraviolet light. The fluorescence of the pigment added to the stucco makes it possible to detect and quantify the whole of the intervened pictorial surface. Eduardo Mendoza, untitled, 2018, Alhambra and Generalife Board of Trustees, Archive.

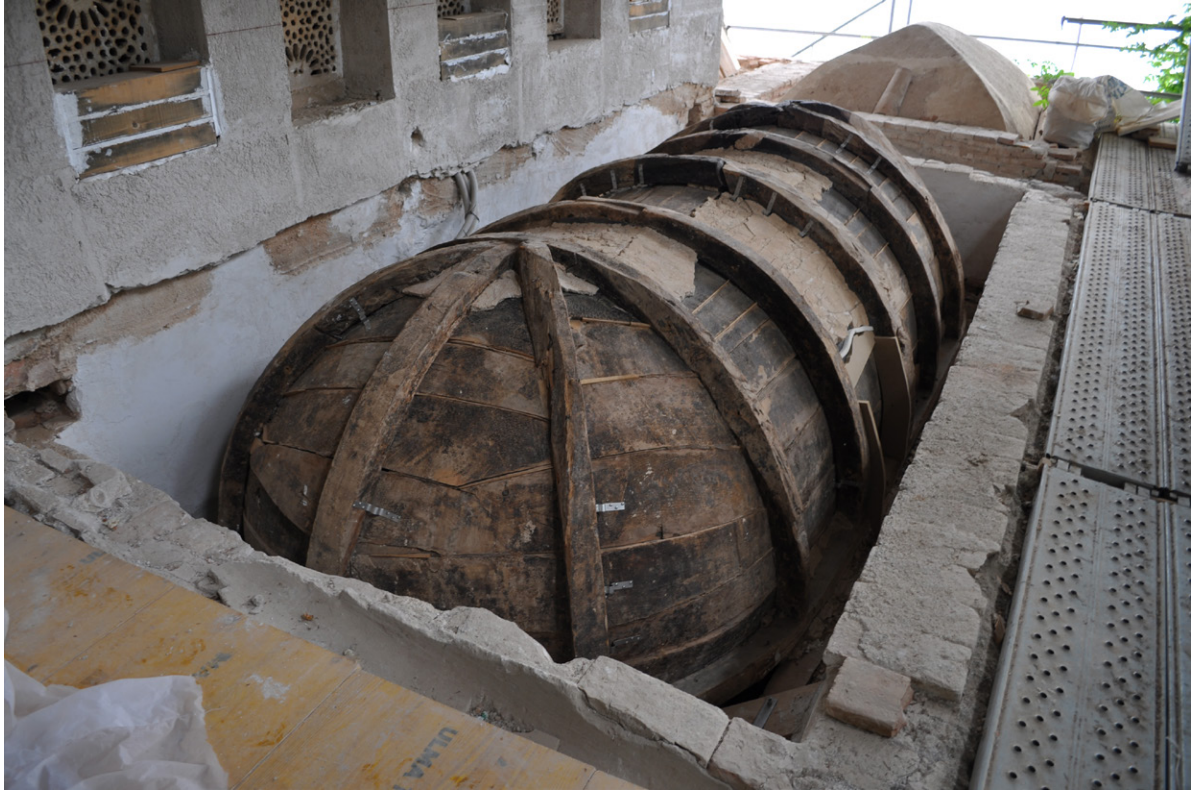
II.14 Extrados of the north vault (The Fountain of Youth) after the restoration of the reverse side. Distinguishing features include the framework formed by the ribs and the triangular shape and arrangement of the planking that makes up the caps. The dark stains correspond to the remains of the originally applied pine pitch coating. The light-coloured coatings are fragments of the plaster mortar that protected the reverse sides. Elena Correa Gómez, untitled, 2009, Alhambra and Generalife Board of Trustees, Archive.

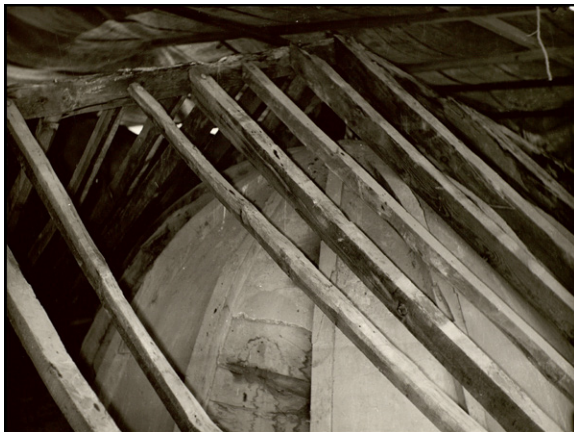
II.15 Extrados of the hemispherical frame of the west temple of the Palace of the Lions in 1966 during the intervention of Prieto Moreno, at the time of the dismantling of the roof and before the restoration of the frame. The architect covered the wood with an orange layer of minium, which was used as a preventive barrier against attack by xylophagous insects due to its lead content, and renewed the plaster cladding. Unknown author, Palace of the Lions. Small temple of the Palace of the Lions. Consolidation works. Phase 1, 1966, Alhambra and Generalife Board of Trustees, Archive, F-020738.

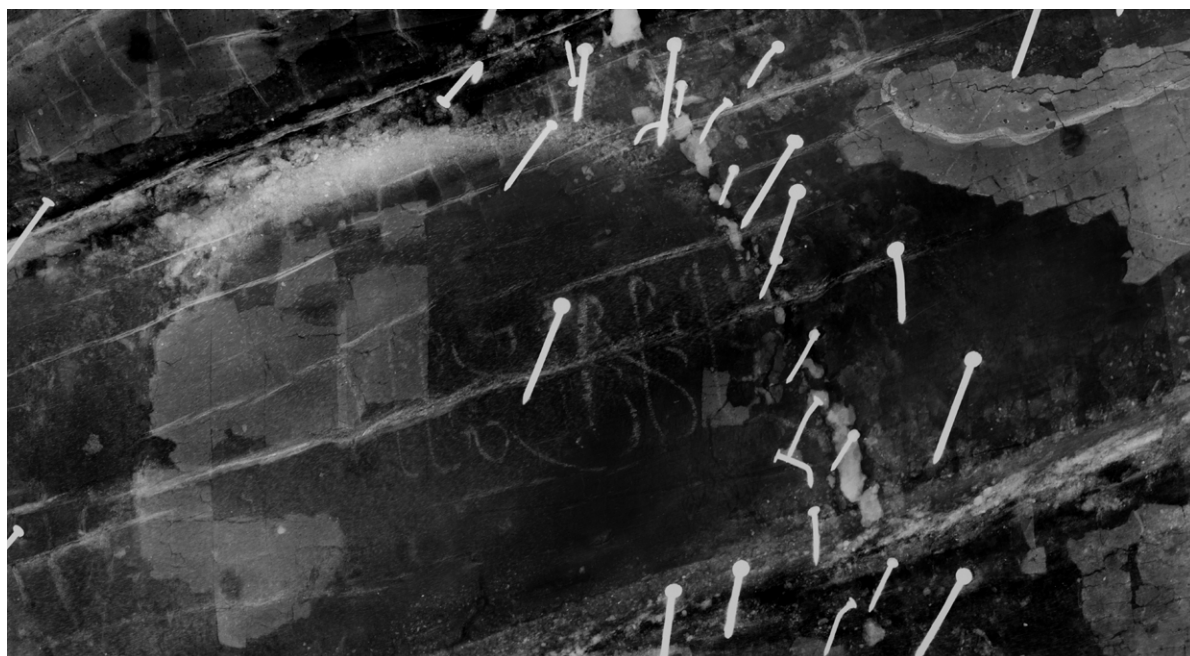
II.16 Arabic lettering appears in the central vault on the reverse of the leather. The state of conservation of the poplar wood, which appears to have been attacked by cubic rot, the superimposition of the deteriorated leather, the remains of the original paint and the wax stuccoes provide a confusing image that makes it difficult to read. Applus, X-ray B2CE2-4, 2010, radiographic plate, Alhambra and Generalife Board of Trustees, Archive.
