COMPLETE RESTORATION OF THE ROOFS OF THE HALL OF THE KINGS

RESTAURACIÓN INTEGRAL DE LAS CUBIERTAS DE LA SALA DE LOS REYES

PEDRO SALMERÓN ESCOBAR

PHD IN ARCHITECTURE. CONSERVATOR OF THE CATHEDRALS OF GRANADA AND JAÉN
estudiopedrosalmeron2@gmail.com

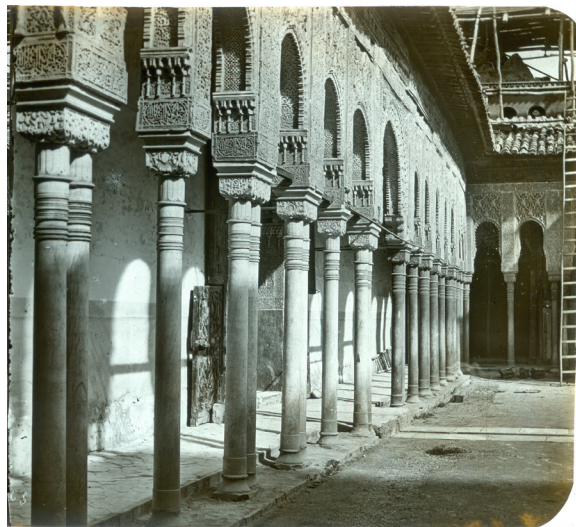
Il. 5. Soulier, 1857, photograph. Courtyard of the Lions. Carlos Sánchez Gómez Collection. The beginning of Rafael Contreras' restoration work can be seen in the background of the photograph. Once the roof was removed, the back of *muqarnas* vault M6 of the Hall of the Kings emerged.

There were certain problems at the point where the lattices are found on the perimeter of the three main areas with *muqarnas* domes in the Hall of the Kings (M2, M4 and M6), which play a important role in how the spaces are perceived, and in letting light in and the spaces transpire through their connection to the courtyard. The envelope of these three vaults partially received light through openings in the perimeter, and those facing the Courtyard of the Lions are visible in historical photographs and engravings. The rest of the lattices embedded in the openings were used for ventilation via the roof chamber, establishing a decisive air flow that helped to preserve the interiors, the roof framework and the *muqarna* and wooden vaults by preventing condensation from generating damp (Il.3) (Il. 4) (Il. 5).

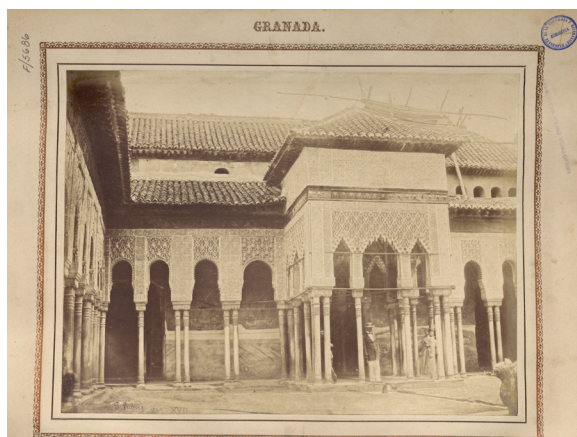
Il. 4. Pedrosa i Vacarissas, Joaquín, 1857, photograph. Courtyard of the Lions. APAG / Photography Collection / F-005689. The Hall of the Kings still has its single roof and the latticed openings in the areas with *muqarnas* vaulting can be seen.

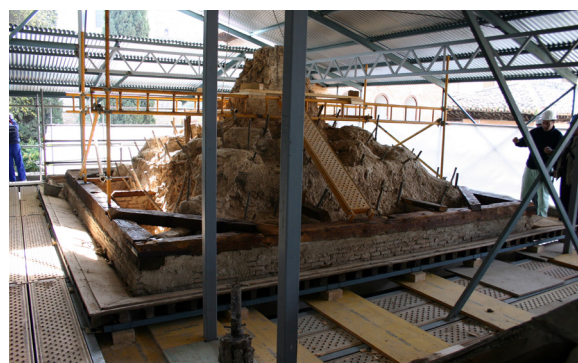
Il. 8. Pedro Salmerón Escobar, 2007, photography. View of the back of *muqarnas* vault M2. Restoration work protected by the cover placed over the entire area of the Hall of the Kings.

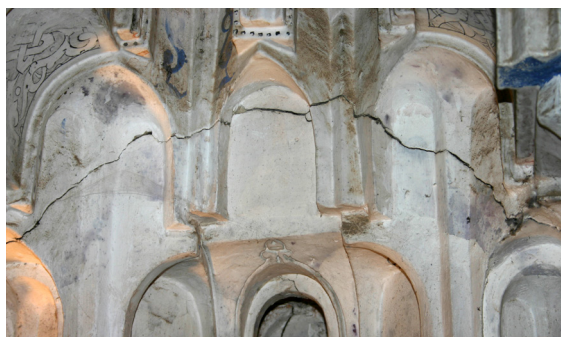
Il. 10. Pedro Salmerón Escobar, 2007, photography. Cracking typical to the accumulated deterioration of the *muqarnas* vaults.

This action is described first because once work had begun on the roofs of the alcove area, deterioration in the others was analysed; emergency measures were taken when serious conservation problems were noted in the main pavilions of the Hall of the Kings. A detailed examination of the *muqarnas* vaults revealed the following deterioration: presence of damp, multiple cracks in the *muqarnas* vaults, deformations in their geometry, the appearance on the underside of circular marks 3 cm in diameter, indicating an inadequate hanging system and a lack of support from the vertical plasterwork cladding caused by fatigue across the entire system¹⁰ [Il. 9] (Il. 10) (Il. 11).

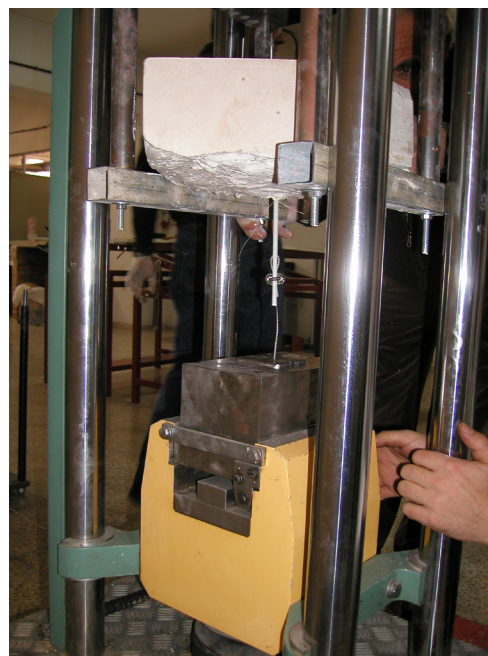
Il. 15. Pedro Salmerón Escobar, 2007, photography. Testing of the tensiometer and anchoring of the suspension system used in *muqarnas* domes M2, M4 and M6. Test carried out by Juan de Mata Vico Rodríguez in the laboratories of the Granada School of Architectural Technology laboratories (now ETS Building Engineering).

The new suspension is designed to withstand tensile stress but is very elastic when earthquake movements push or try to push the *muqarnas* dome towards the roof or when deformations in the roof act on the *muqarnas* dome. To carry out this work precisely and to check the effectiveness of the proposed system, a test was planned in the laboratory of the School of Technical Architecture of Granada (2007), which made it possible to define the effectiveness of the solution. Several plaster blocks were made and drilled with a 3 cm diameter hole, where the bulb attached to the stainless steel cable was anchored with plaster and tow. Once the plaster had set and dried, the results of the tensile test were satisfactory, proving that pull-out was produced at tensions far higher than the real stress found at each support point (Il. 15) (Il. 16).

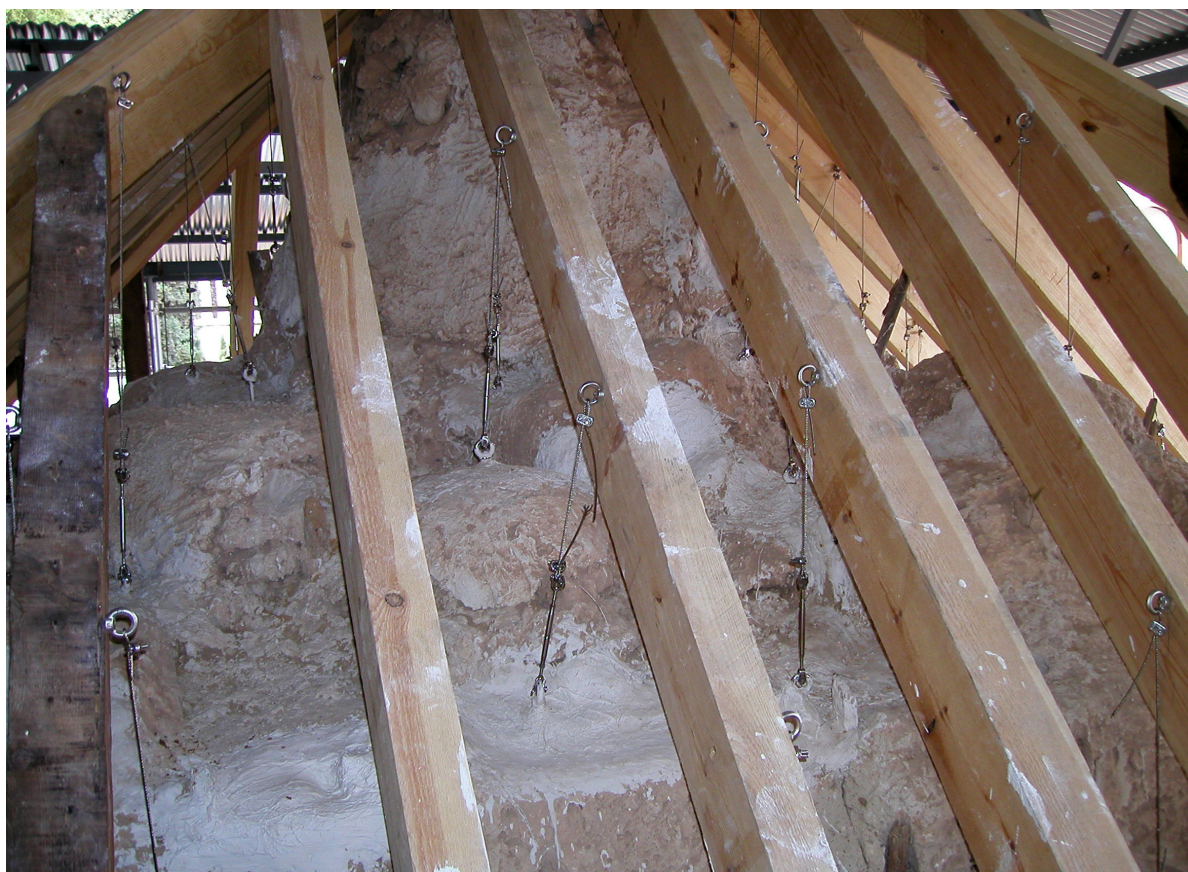
II. 16. Pedro Salmerón Escobar, 2007, photography. Tensioners placed in the new wooden framework for the elastic support of *muqarnas* vault M2.

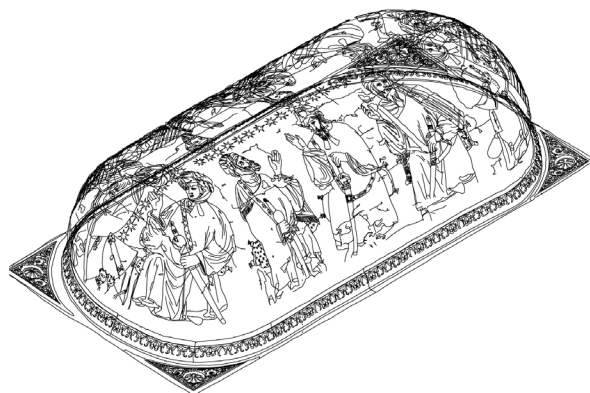
Il. 17. Saturio Estebarez, CONSULTING TOPOGRÁFICO S.L., drawing, 1999. Photogrammetric survey. 3D display of vault B2. Tracing of the important figures in the painting of this vault that gives it the name of the Hall of the Kings.

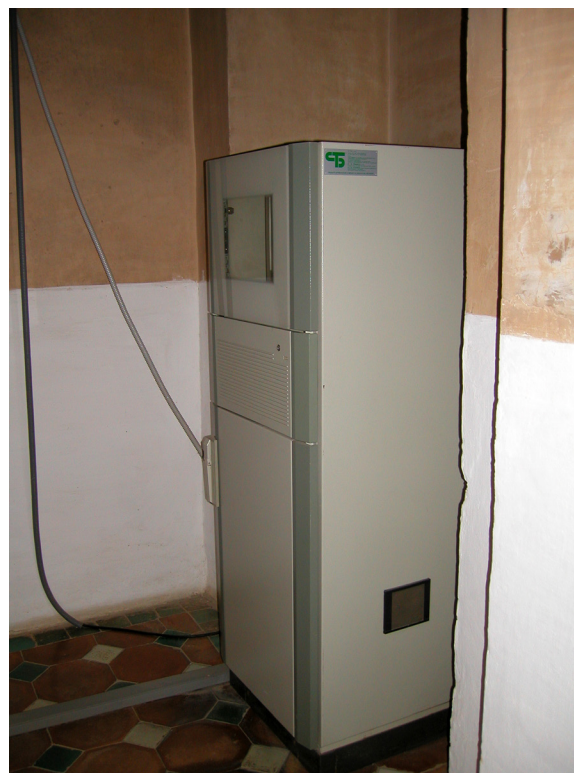
Il. 18. Pedro Salmerón Escobar, 2003, photography. Micro-climate point installed in the Hall of the Kings for initial environmental monitoring (agreement with the IAPH).

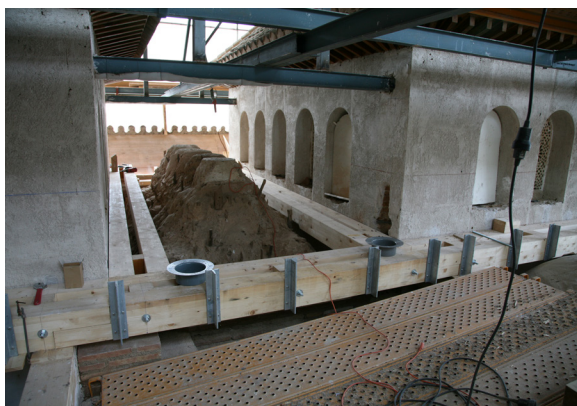
Il. 21. Pedro Salmerón Escobar, 2010, photography. Double glued laminated timber beam supporting the main channel and the structure. Positioning of PVC drains. The back of *muqarnas* vault M5 can be seen between the main pavilions M4 and M6.

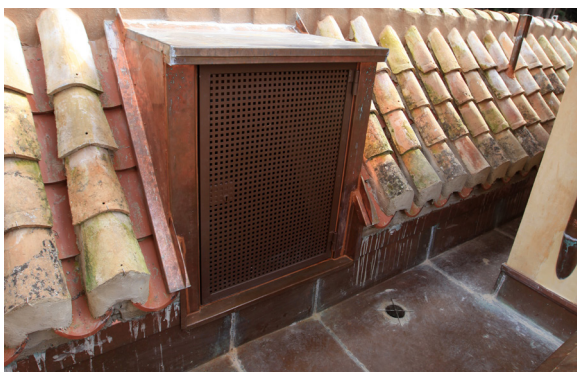
Il. 22. Pedro Salmerón Escobar, 2011, photography. Copper plate finishes on main channels and embrasure for access to roof for maintenance. A static Hoover in sheet copper can be seen in the background.

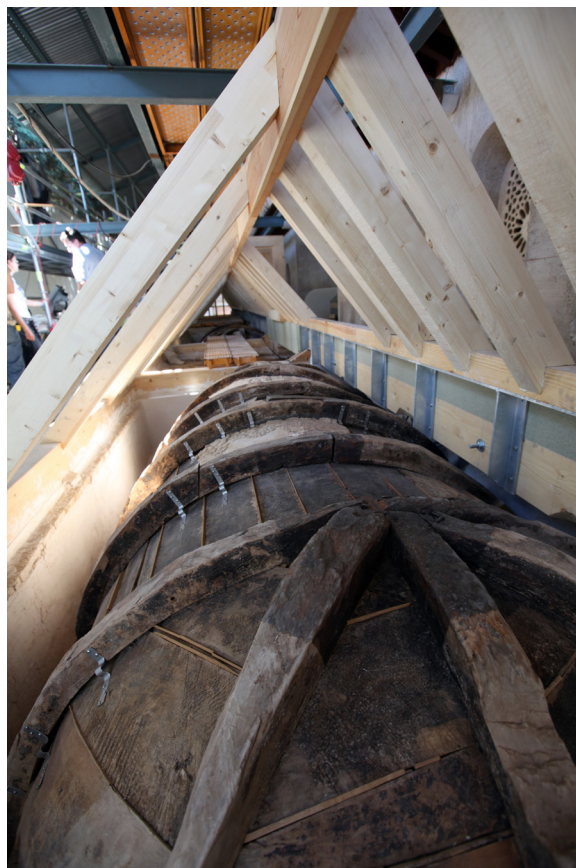
Il. 23. Pedro Salmerón Escobar, 2010, photography. New wooden roof frame over the painted wooden vaults. Vault B3 in the foreground where the ribs and curved and assembled boards can be seen.

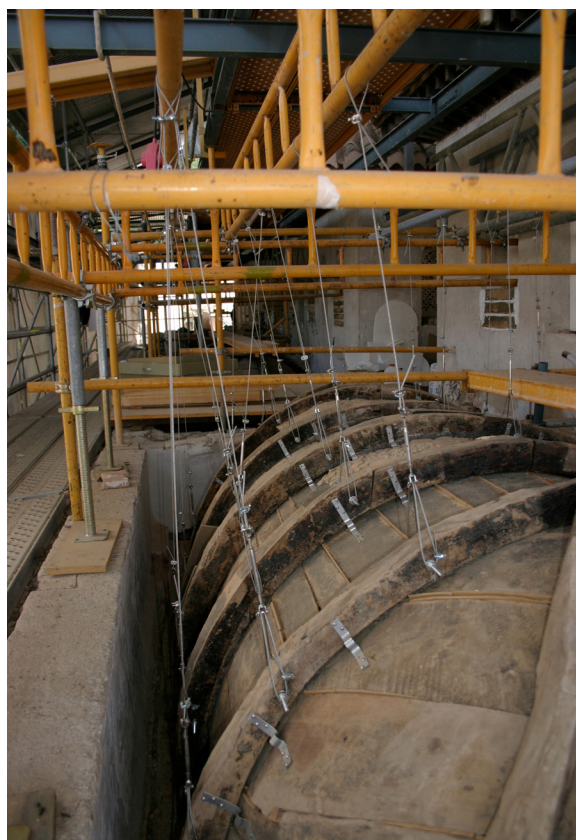
Il. 27. Pedro Salmerón Escobar, 2009, photography. View of the suspension system used in vault B3 using auxiliary scaffolding.

The idea of the project was to make the vaults self-supporting again by repairing or restoring the main resistant elements of the vault itself, especially the ribs and perimeter base, and by restoring and replacing all the supports around the vault. When comprehensively restoring the reverse sides, including all their components, curved boards and ribs, a initial difficulty arose: it was impossible to access the support areas to carry out in-depth work, which sometimes required the partial replacement of areas lost due to rotten wood. To solve this problem and leave the area completely free to work, a vault-to-vault hanging system was designed, consisting of an auxiliary scaffolding stretched over the vaults for suspension using braided stainless steel cable with flanges at the ends and equipped with a tensor to make the adjustments. Temporary fixings were made to the cross ribs with through bolts, choosing a suitable position that wouldn't damage the structure. The system, which can be seen in the attached pictures, involved literally hanging each vault and freeing up the lower area of the shoring board and polystyrene *counter-forms*, allowing the entire structure to be safely repaired. (Il. 26) (Il. 27)

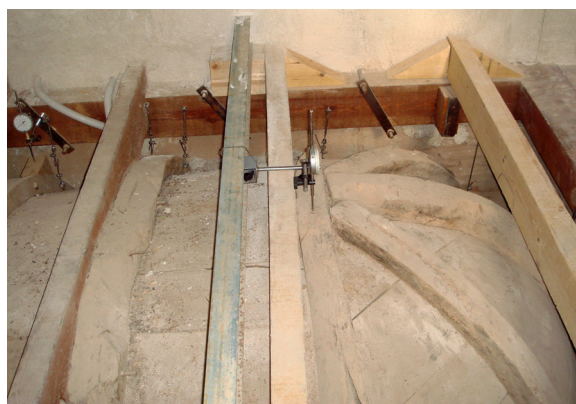
Il. 28. Pedro Salmerón Escobar, 2008, photography. View of the suspension system used in vault B1, reusing the wooden beams installed in the 1976–1983 restoration. Extensometers used in the load test can be seen.
