# THE WOOD SUPPORTS OF THE PAINTINGS IN THE HALL OF KINGS: A TECHNICAL STUDY OF ITS CONSTRUCTION, STATE OF CONSERVATION AND TREATMENT

BENJAMÍN DOMÍNGUEZ-GÓMEZ

UNIVERSIDAD DE SEVILLA

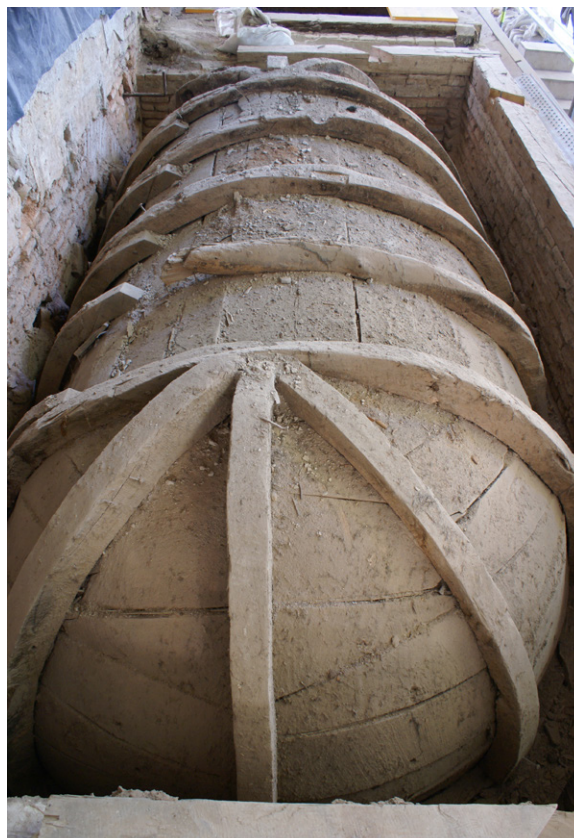
Il. 1: Vault 2. Photograph prior to the intervention. Benjamín Domínguez, Vault 2. Photograph prior to the intervention.

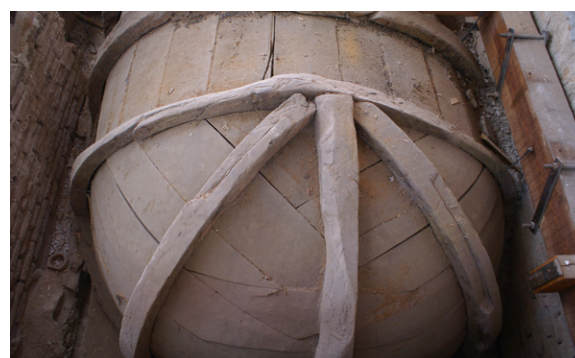
Il. 2: Vault 1. Photograph prior to the intervention. Detail of the construction system. Benjamín Domínguez, Vault 1. Photograph prior to the intervention. Detail of the construction system, 2007. GESTIONARTE S.L.U.

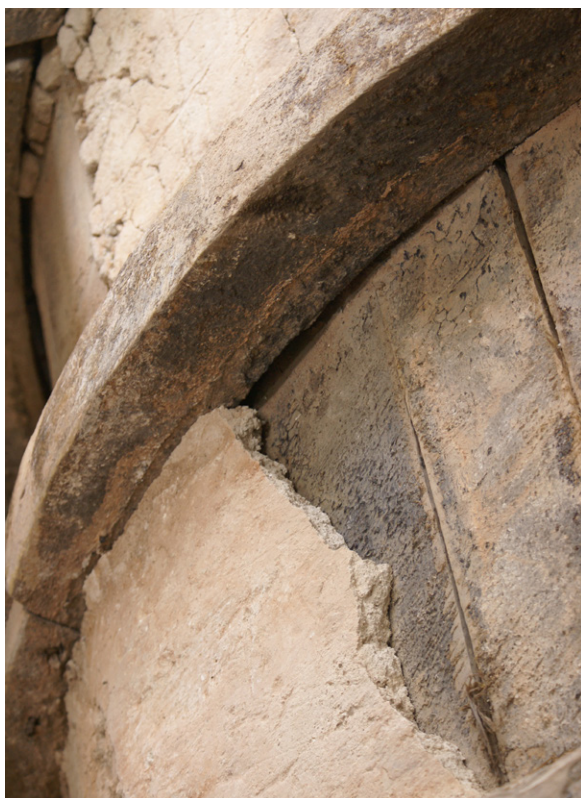
Il. 3: Vault 3. Detail of the two covering layers, resinous layer and plaster. Benjamín Domínguez, Vault 3. Detail of the two covering layers, resinous layer and plaster, 2008. GESTIONARTE S.L.U.
