THE MUQARNAS DOMES OF THE HALL OF THE KINGS: DATA FOLLOWING THEIR RESTORATION

RAMÓN FRANCISCO RUBIO DOMENE

HEAD OF THE PLASTERWORK AND TILING RESTORATION WORKSHOP OF THE BOARD OF TRUSTEES
OF THE ALHAMBRA AND GENERALIFE. PHD IN RESTORATION, UNIVERSITY OF GRANADA.

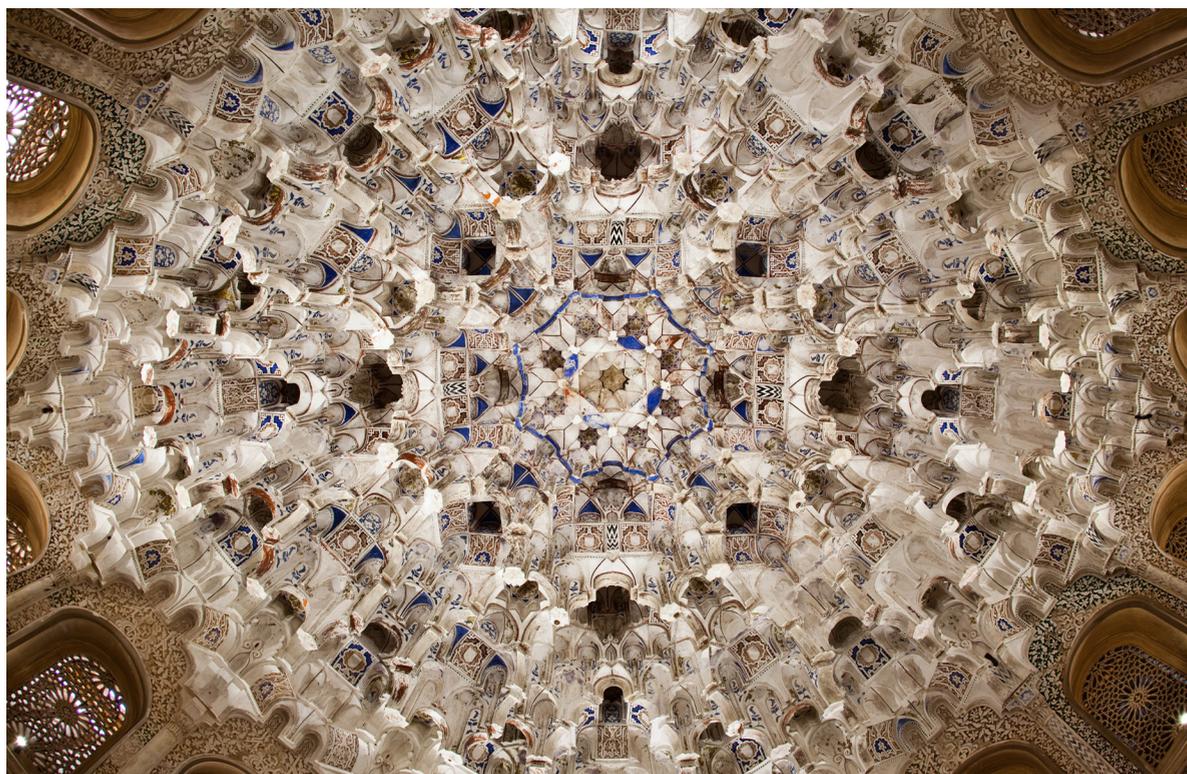
Il. 2. General view of muqarnas dome 6.

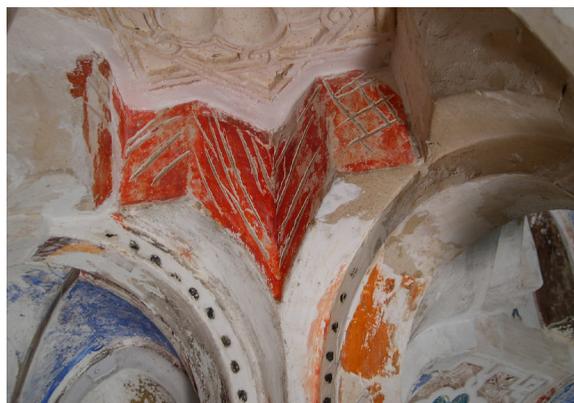
in the images below, sometimes reaches up to 7 cm. The image above shows large forged angled nails (in blue), which were introduced in later 19th century works to guarantee its stability and prevent it from collapse.
